HICKSON ROAD UPGRADE - STAGES 3 & 4

HISTORICAL ARCHAEOLOGICAL ASSESSMENT & IMPACT STATEMENT

NOVEMBER 2025

FINAL REPORT | to Infrastructure NSW and Lendlease (Millers Point) Pty Ltd

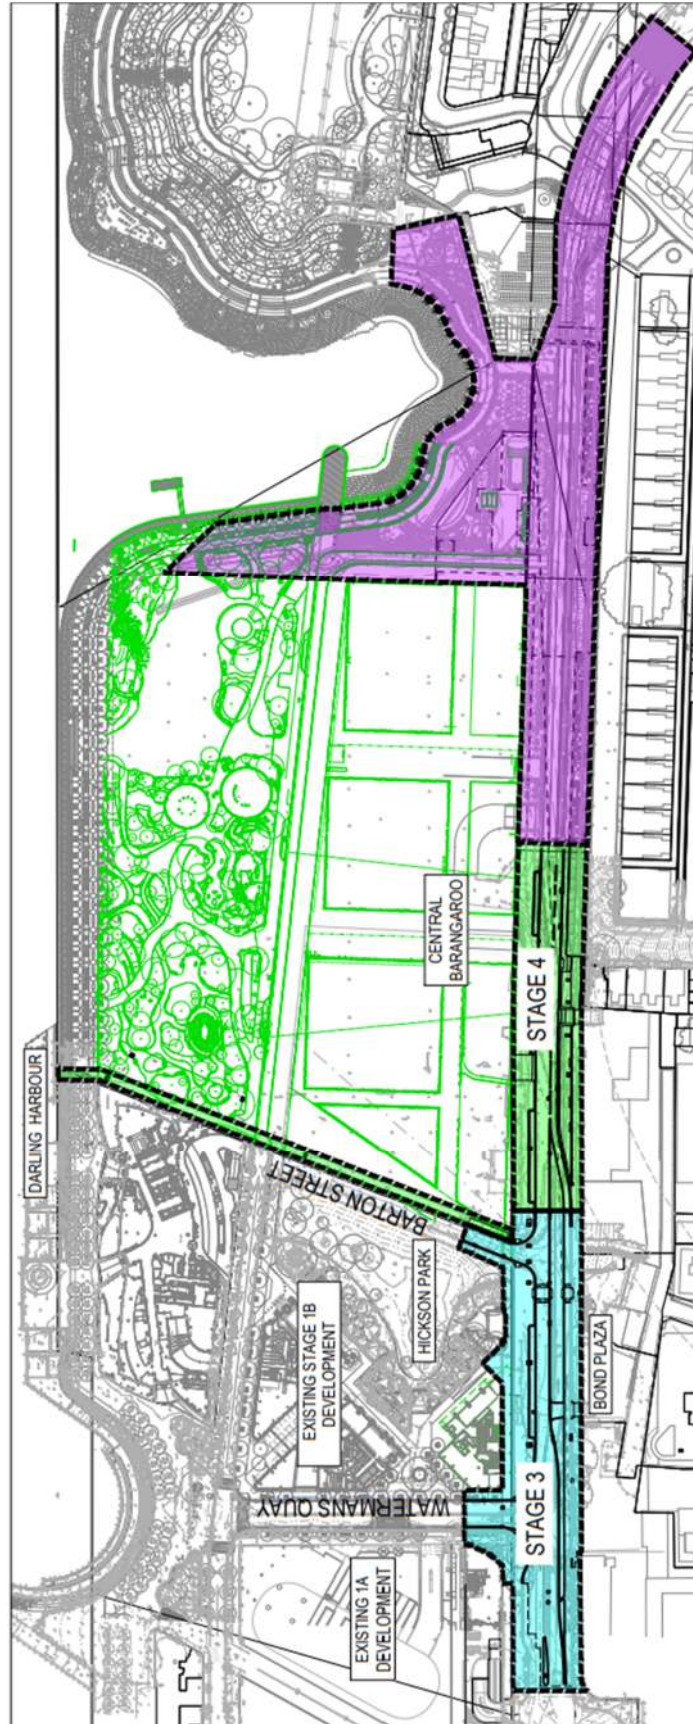
Figure 1.2: Staging plan for the Hickson Road South project; Enspire Solutions Pty Ltd, 240059-00-REF-C01.31..

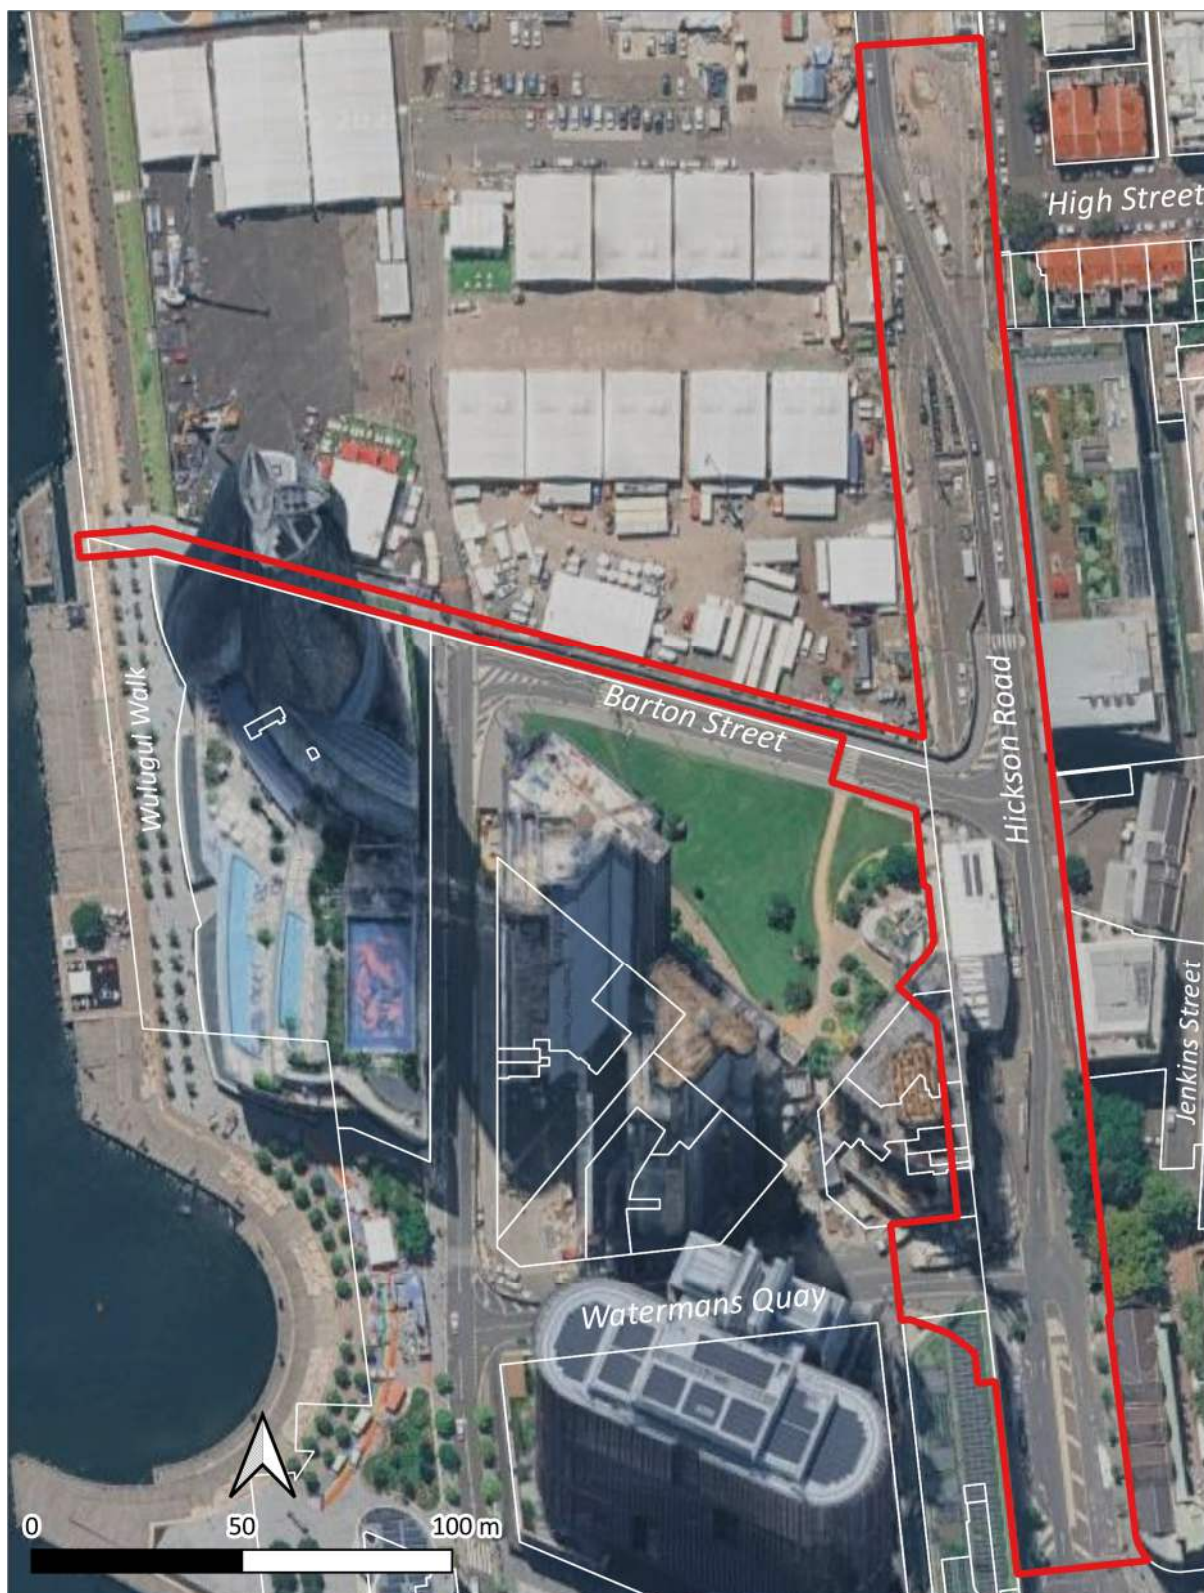
Figure 1.3: Plan of the Stage 3 and 4 Hickson Road Upgrade Works, with the study area outlined in red. Note the large white structures to the west of Hickson Road were erected above the areas of gasworks remediation. Google Earth 28/02/2023.

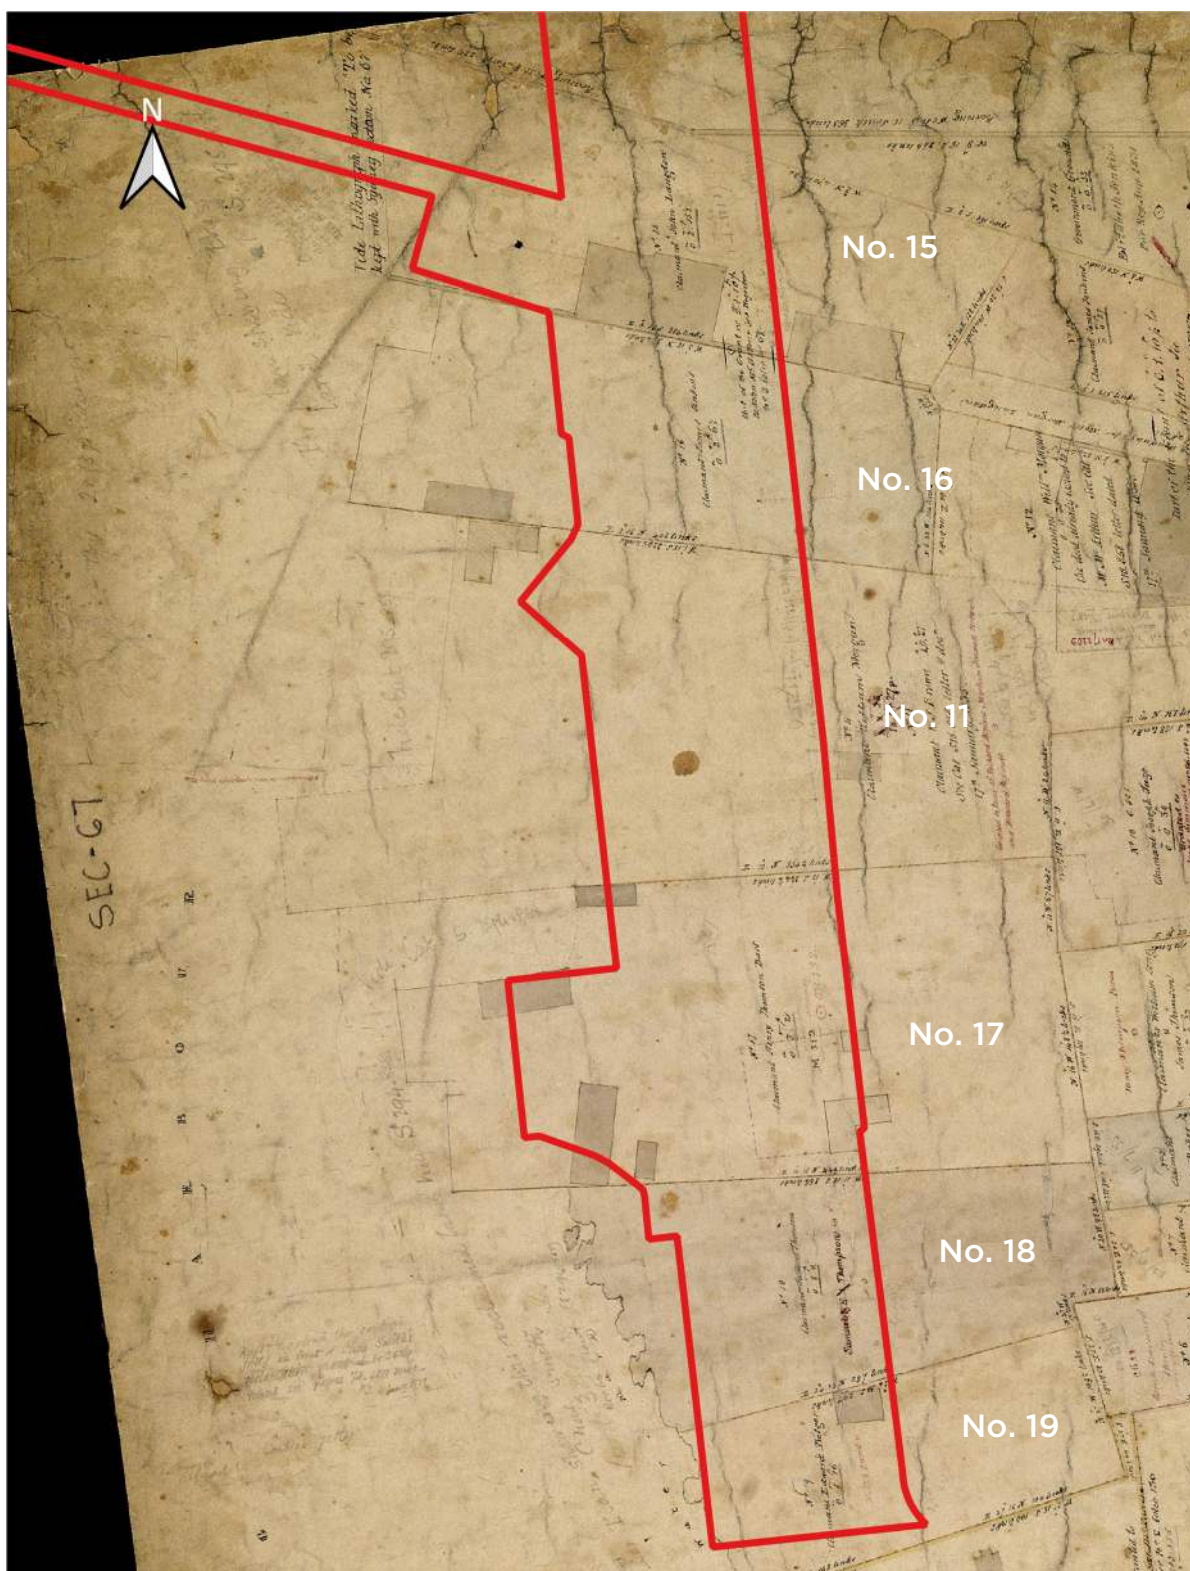
Figure 3.7: 1834 plan showing the 1830s allotment grants and owners. The structures within the study area can also be seen on the earlier 1833 plan (Figure 3.6). Sydney Section 67 (Crown Plan S.45.684) by Robert Russell dated 18 November 1834. NSWSA, AO Map 5421.

Robert Russell's plan of Sydney Section 67 dated November 1834 identifies the boundaries of the allotments in the southern portion of the study area (Figure 3.7).²¹ These allotments to the west, with access to the Darling Harbour shoreline, were considerably larger than those along Kent Street. The 1834 plan also shows the buildings on the allotments, some of which can be identified on the earlier 1823 Harper plan (Figure 3.4, Figure 3.5). In a sketch prepared by Russell the following year (Figure 3.8), the landscape does not appear as steep as in earlier depictions (Figure 3.3), however the rocky nature of the foreshore has evidently still constrained development of the area, such that most structures are situated on higher ground and only several wharfs or jetties are present along the waterfront.

Thomas Agar, Henry Bass and Francis Girard had extended their properties into the harbour through reclamation or the construction of private wharfs. These early reclamation events in the southern part of the study area, are illustrated on Russell's plan dated to 1834 (Figure 3.7).²⁶

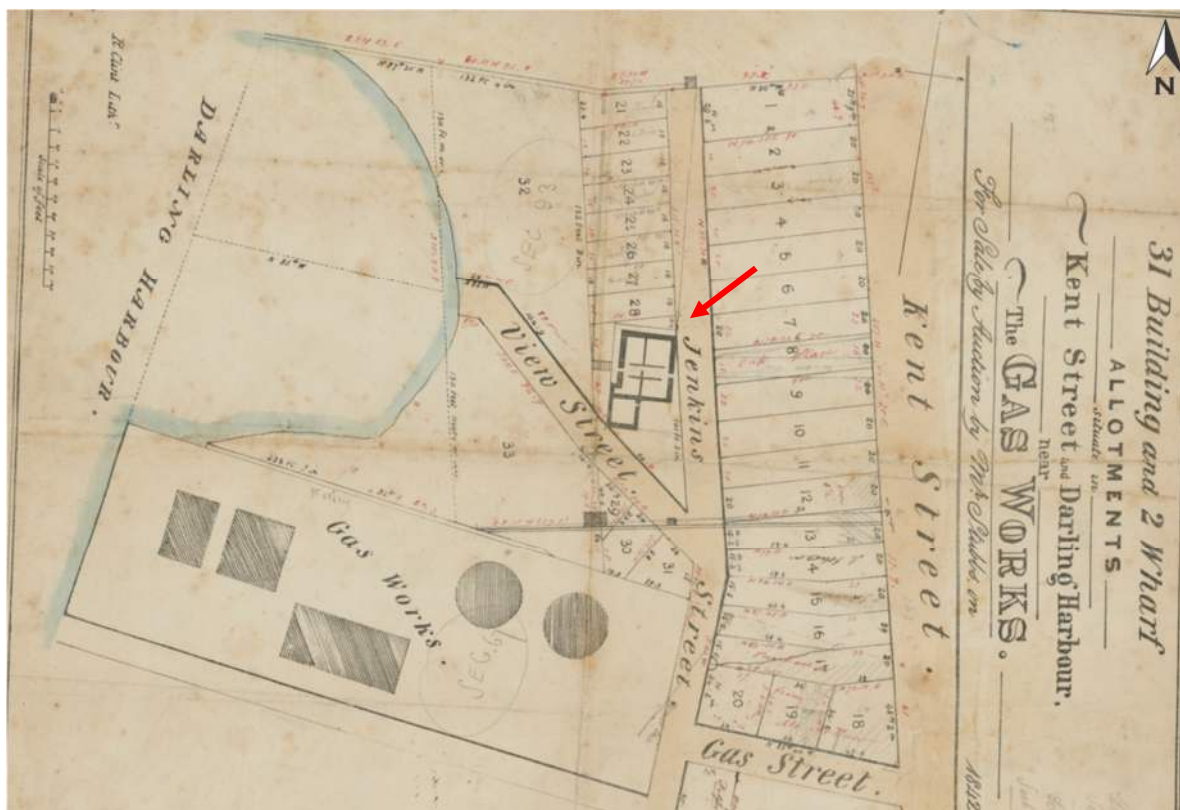
Figure 3.12: The footprint of James and Elizabeth Jenkins' house (arrowed) is to the north of the AGL site between Jenkins and View Streets in this 1842 plan. The earliest iteration of the gasworks, erected in 1839, is clearly marked, although there are some inaccuracies (see Figure 3.21). '... allotments... near the Gas Works'. SLNSW ML, ZM2 811.171/1831/1.

(c.1052 ha) of land outside Sydney by 1828.³² Jenkins lived near Darling Harbour, just to the north of Macarthur's land in Millers Point, and built a substantial house on government land, where he lived with his wife Elizabeth, the Australian-born daughter of two convicts. The footprint of this house, between the new streets Jenkins and View, is shown in an 1842 plan (Figure 3.12). James died in 1835 and Elizabeth inherited his property. In 1843 she remarried. Her new husband, William Burnicle, another shipwright, died three years later: Elizabeth survived until 1874.³³ Elizabeth's lands in Millers Point were usually referred to as the 'Jenkins estate'. Following Elizabeth's death, part of Lot 1 was acquired by the AGL Co for the expansion of the Gasworks further north, including the construction of the largest gasholder.

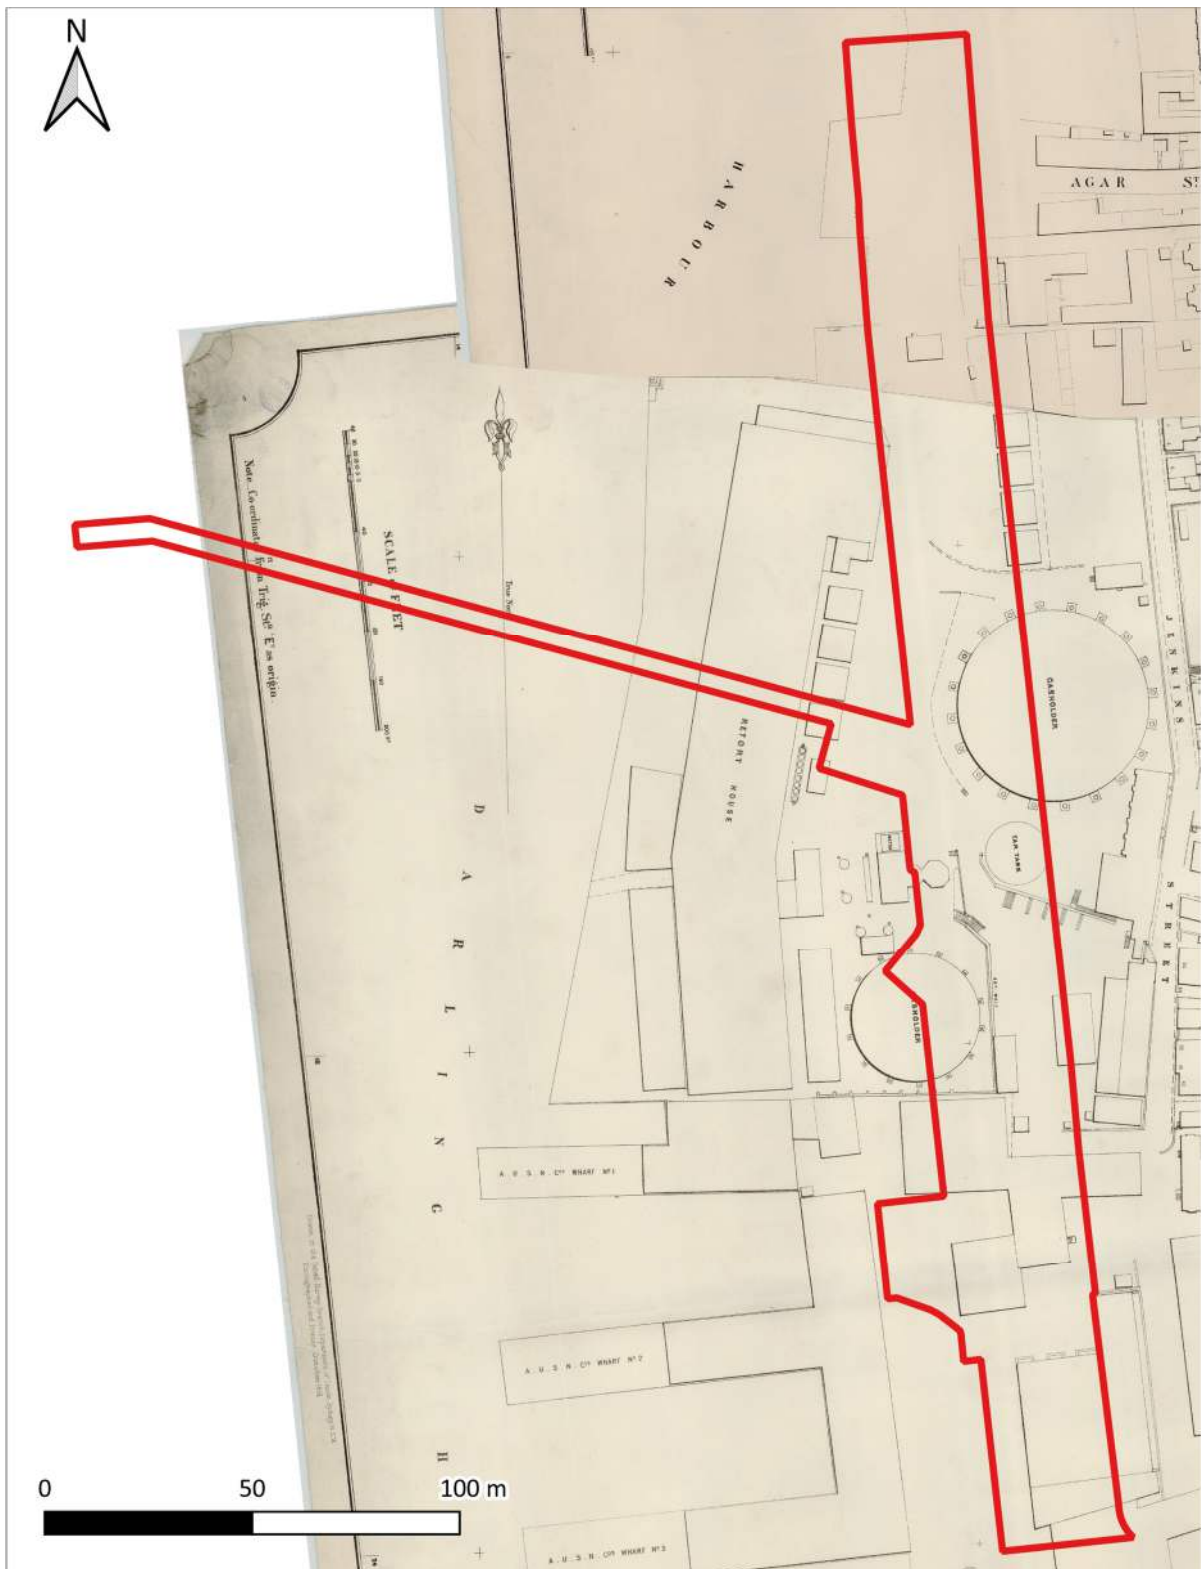
Figure 3.17: The study area in 1888-91, showing the northern portion of the study area as having been largely cleared, whereas the Gasworks and Grafton Bond Stores are well established. SLNSW, Metropolitan Detail Series, Sections 67 and 93. ML M Ser 4 811.17/1.

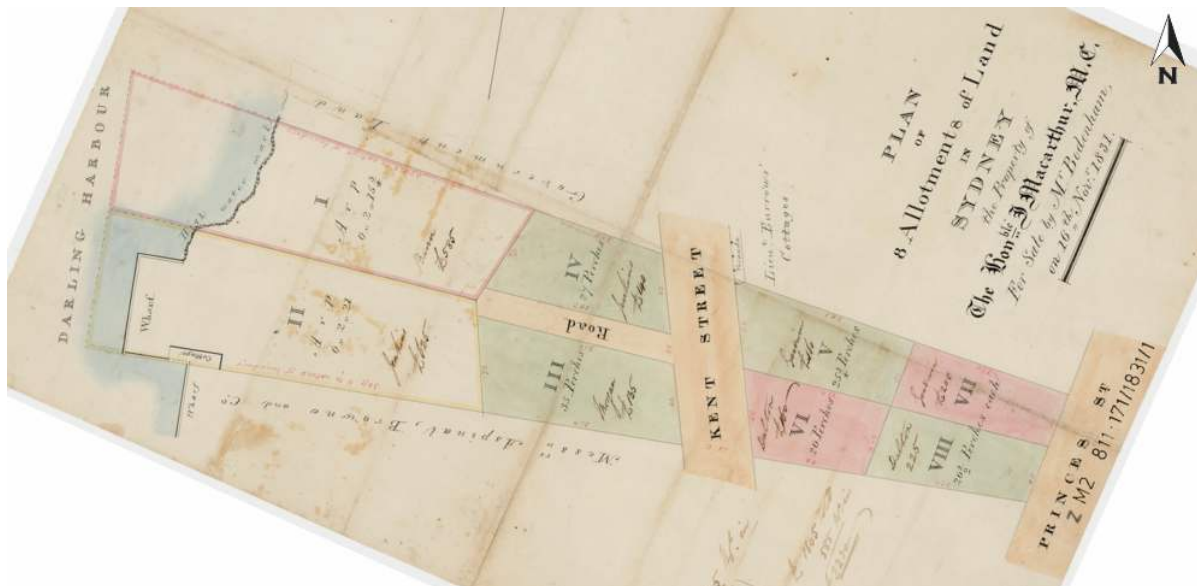
Figure 3.19: John Macarthur's sub-division of his 2¼ acres in Millers Point, offered for sale in November 1831. SLNSW ML, ZM2 811.171/1831/1.

At some stage, however, certainly by the 1820s, Macarthur constructed a wharf and an adjacent cottage on the southern half of his frontage with Darling Harbour.⁴¹ At the end of the decade an army officer, Lieutenant Burrows, built cottages intruding marginally on Macarthur's Kent Street frontage, while Aspinall Browne and Co., prominent merchants and wool-exporters, had taken up the land to the south and built their own wharf adjacent to Macarthur's. In November 1831, however, Macarthur sold the 2¼ acres (c.0.9 ha), divided into eight unequal allotments (Figure 3.19).⁴²

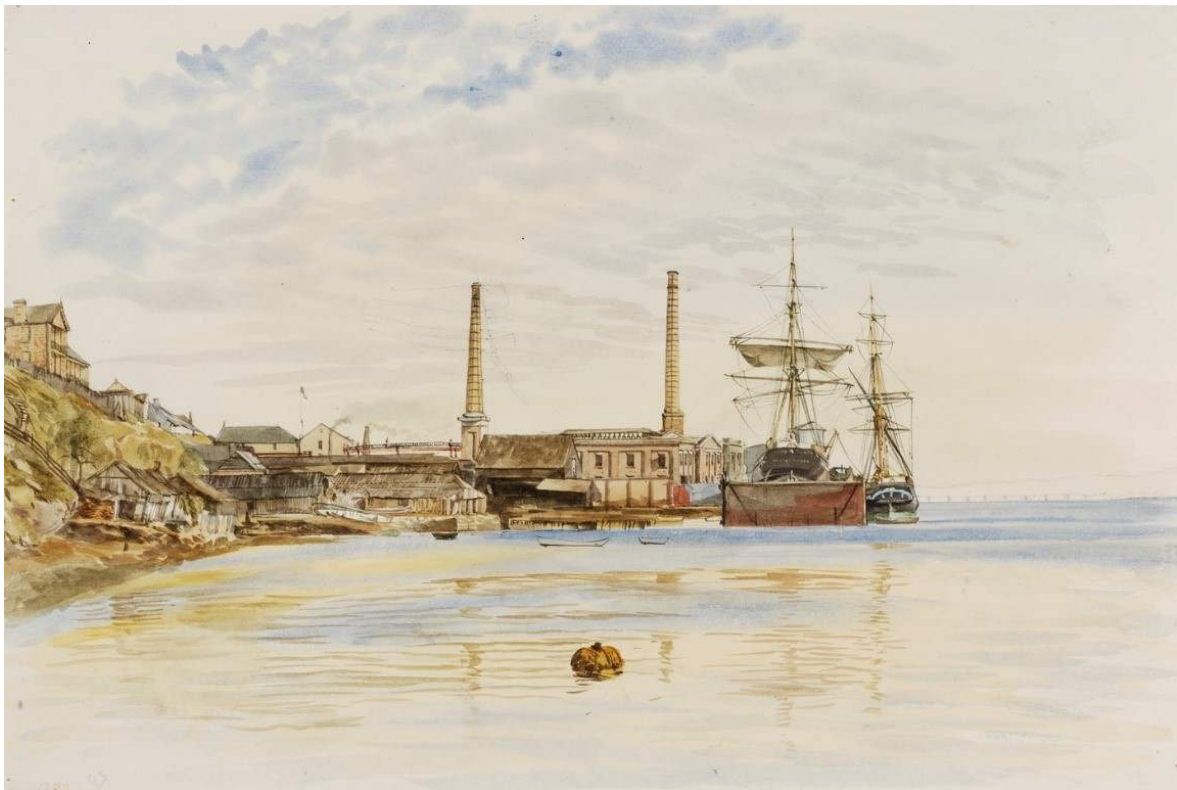
Figure 3.25: View of the gasworks at Millers Point c.1873, watercolour by Samuel Elyard. SLNSW, DGD 5, File No. FL650473.

On top of the engine house there were three large tanks in 1870, some four feet (c.1m) deep (Figure 3.25). One held water for flushing the toilets, one was for ammonia and the third stored tar. Close to the engine house there were 'pits capable of holding from six to eight thousand gallons of tar and liquor'.⁹⁸

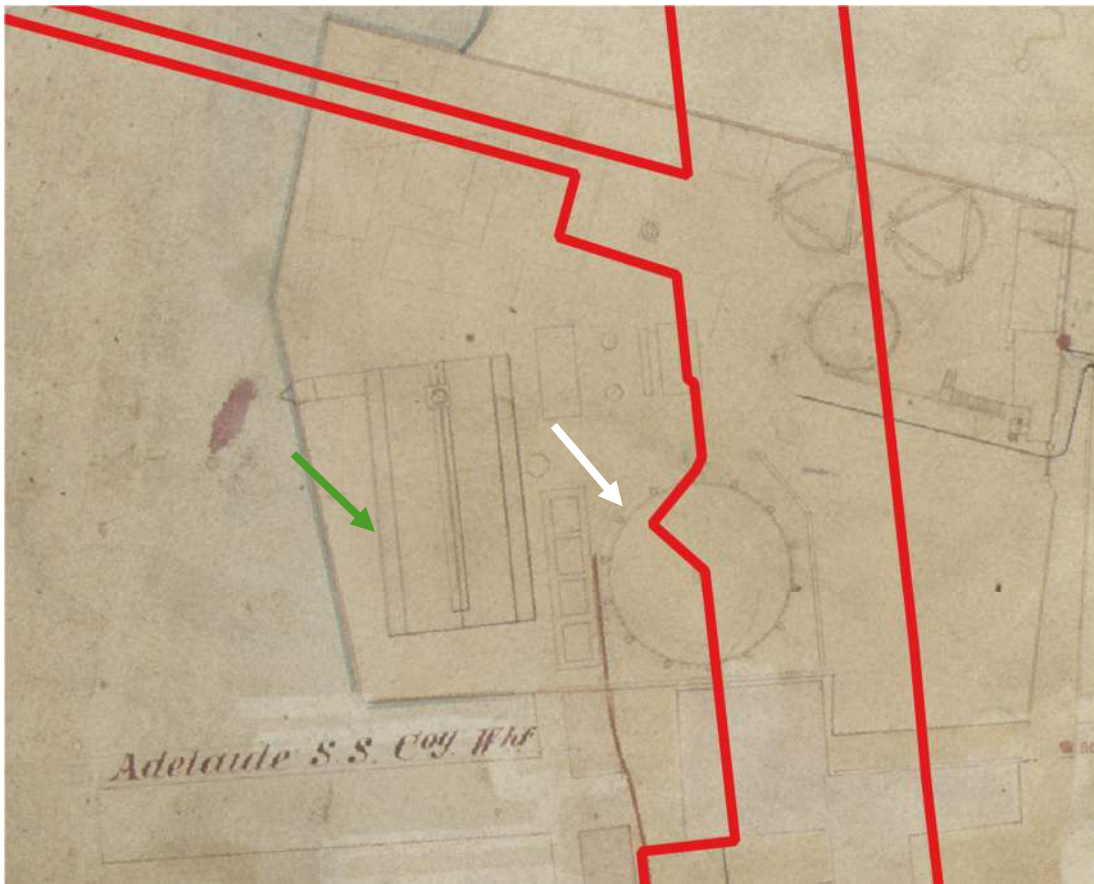
Figure 3.26: Detail of 1870 plan showing the new retort house (green arrow) to the south of the earlier retort complex (pencil outline), which was demolished during 1868. The 1870 gasholder (white arrow) co-exists with the three earlier gasholders, two of which are shown as disabled. 'Australian Gas Light Company Sydney plan of [gas] mains' Sheet 3. SLNSW ML, 811.17/1870/1.

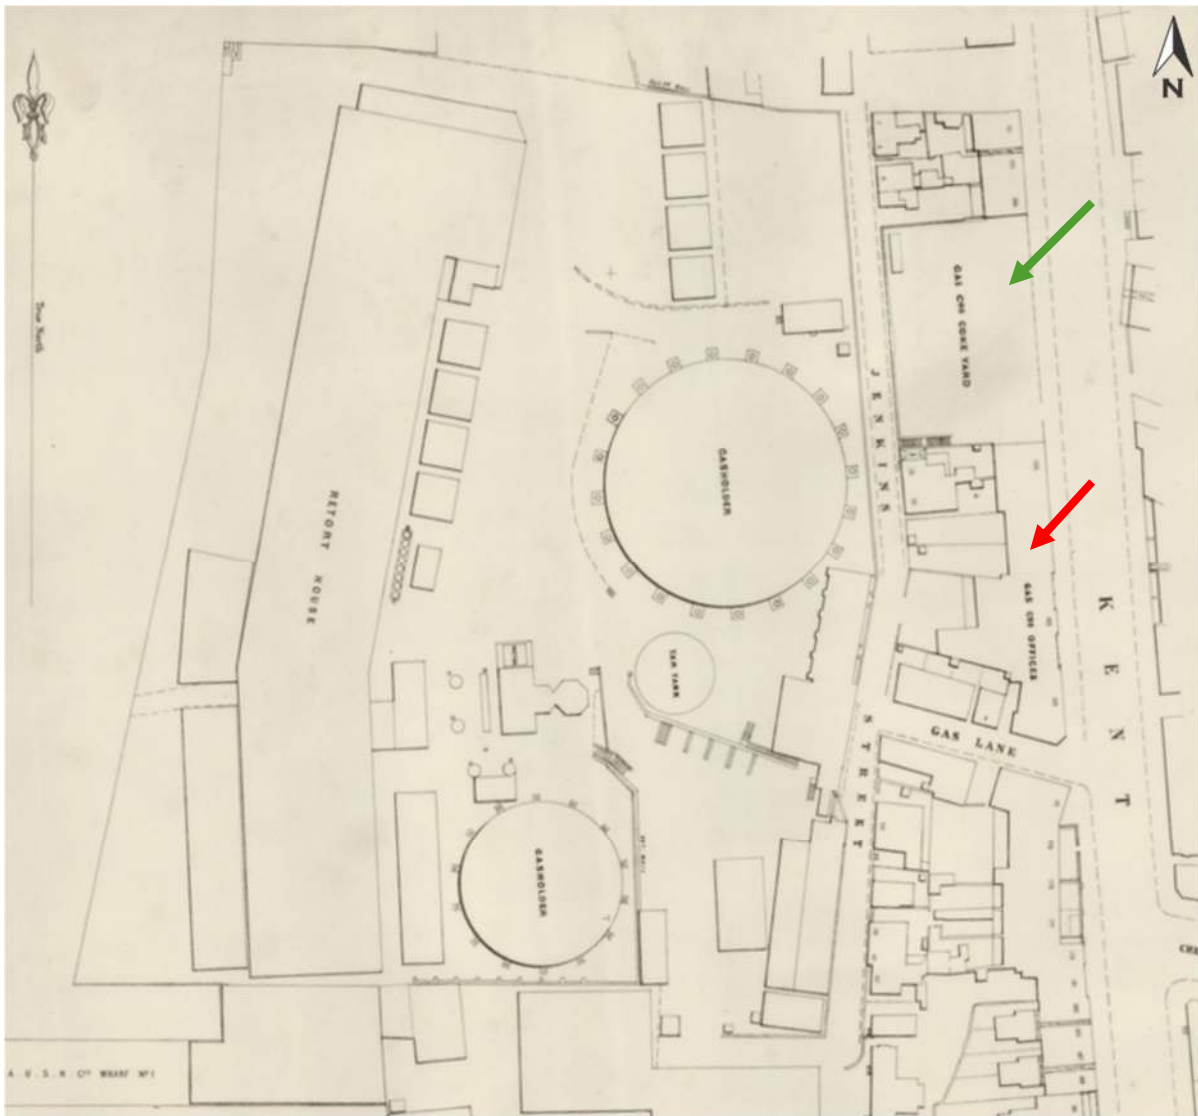
Figure 3.33: The AGL in 1891. Both the 1869-1870 and 1882 gasholders are shown, along with the tar tank, the new coke yard on Jenkins Street (green arrow) and the company offices on Kent Street (red arrow). SLNSW, Metropolitan Detail Series, Section 67. ML M Ser 4 811.17/1.

⁹⁹ Lukey 1897: 11-14; *SMH* 13 Jul 1870, p.10. See the large 'Tar Tank' marked and named on an 1891 plan (see Figure 3.33).

A final, larger, gasholder (no.5) was built close to Jenkins Street in 1882, on land which had to be built up on the western side (Figure 3.31, Figure 3.32). Gasometer no.3 was converted into a large tar tank, which was capped early in the 20th century and concealed by 1911 under the engineers' shop, in use until 1918 (Figure 3.33). Some tar also settled and remained below water level in the annulus of the new gasholder.

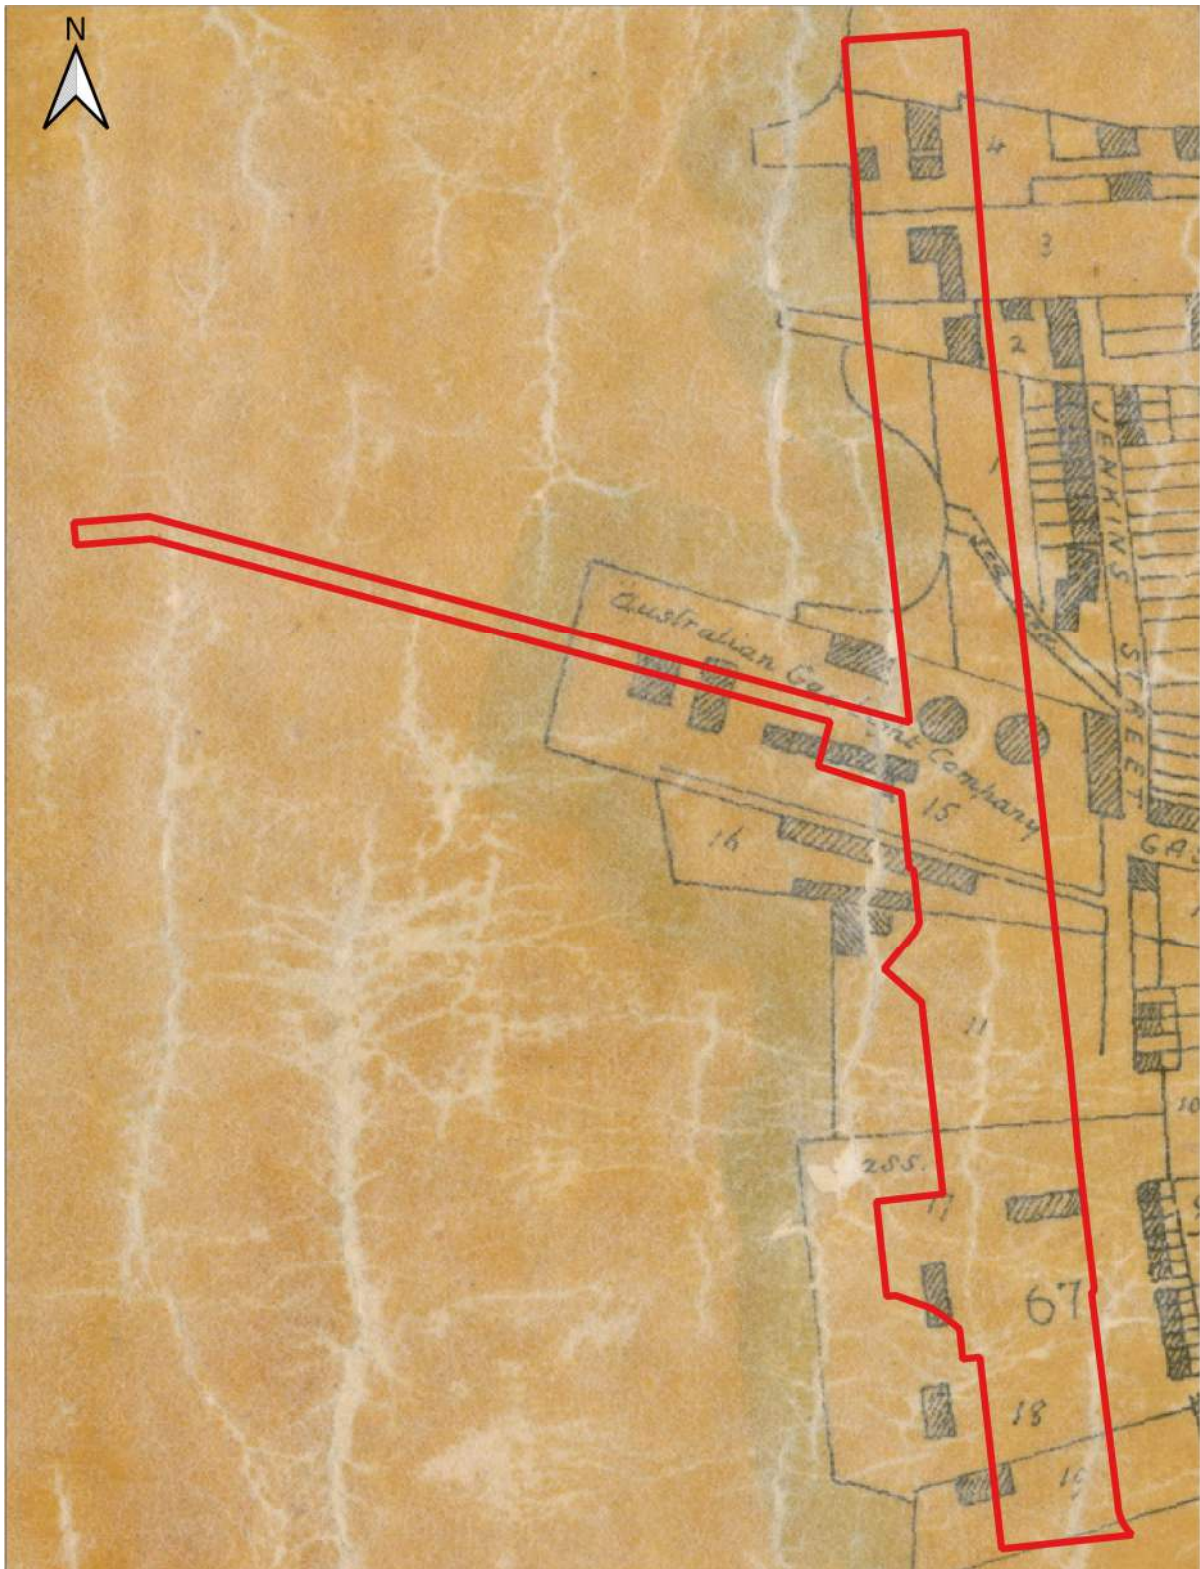
Figure 3.38: 1850 plan showing early Gasworks and still limited structures in the south. 'This plan of the City of Sydney, including the environs of Pyrmont, Balmain, Redfern, Chippendale, the Glebe, Surry Hills, Paddington & c.', William Henry Wells. SLNSW Z/M4 811.17gbbd/1850/1, Sheet 2.

map of the City of Sydney in 1850 (Figure 3.38)¹³⁵ and the 1854 Woolcott & Clarke plan (Figure 3.39) both show the property and buildings. By comparison with his neighbours the rateable valuation of Bass' property was quite low, suggesting that his waterside premises were perhaps not very sophisticated or up to date.¹³⁶ In 1853 Bass sold the land to John Reeve, and in 1854 it was purchased by merchants Charles Smith and John Henry Challis. A year later Smith and Challis also purchased **Edward Boulger's Lot 19**, immediately to the south, which appears to have remained undeveloped since the 1830s, and with this extension to Bass' original holdings began to redevelop the property.¹³⁷

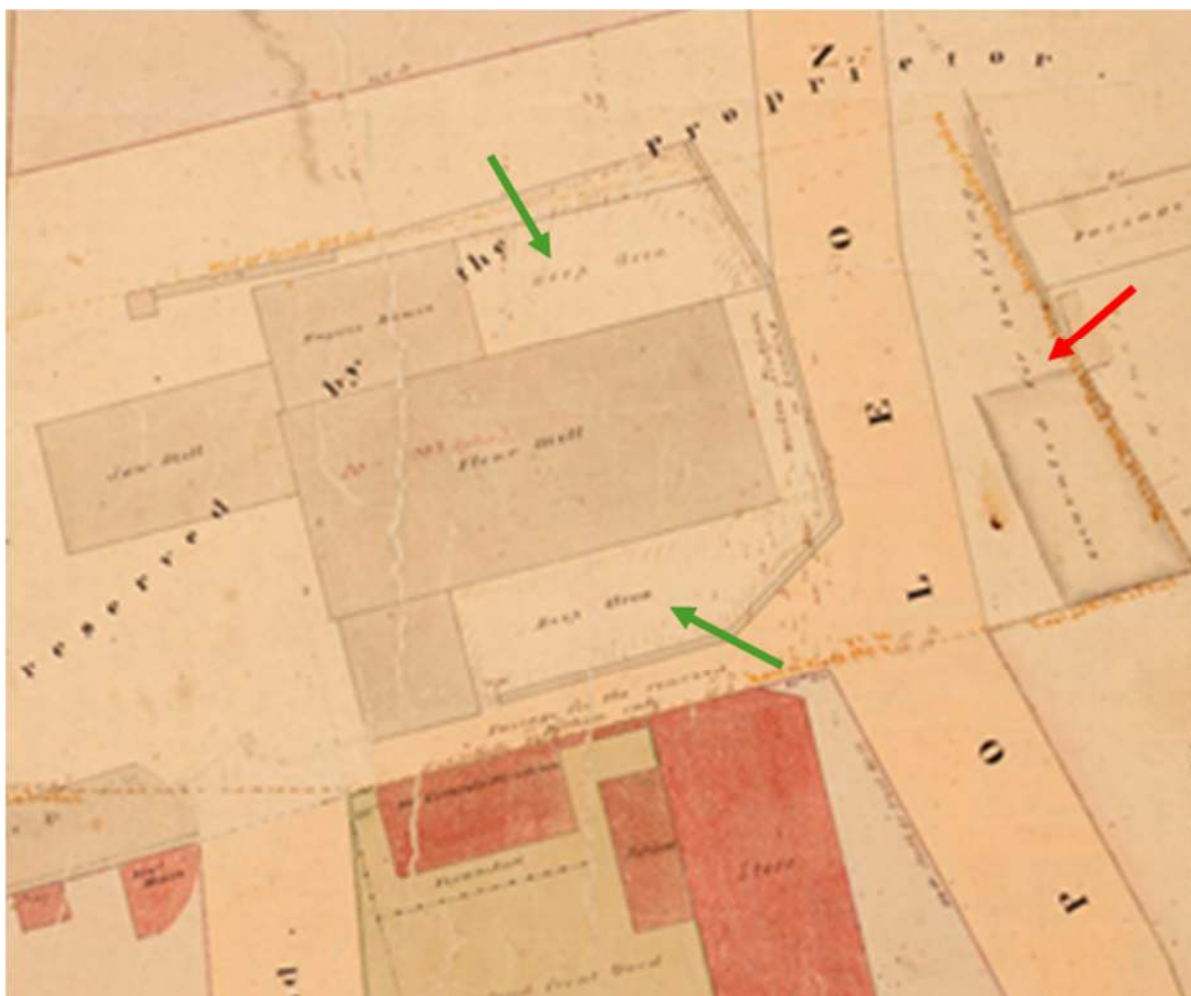
Figure 3.40: A detail of plan of the sale of Girard's Estate which shows evidence of early quarrying in the area around the Flour Mill with the annotations 'deep holes' (green arrows). The red arrow pointing to 'Excavation for building'. This area is further south (outside the study area) but confirms quarrying was taking place within the area in the early 19th century. "Plan of 12 allotments part of Mr. F. Girard's estate, Sydney: to be sold by auction by Mr. S. Lyons, on Wednesday Feb, 12th 1840 / John Armstrong, surveyor." SLNSW, Mitchell Map Collection, Maps/0121.

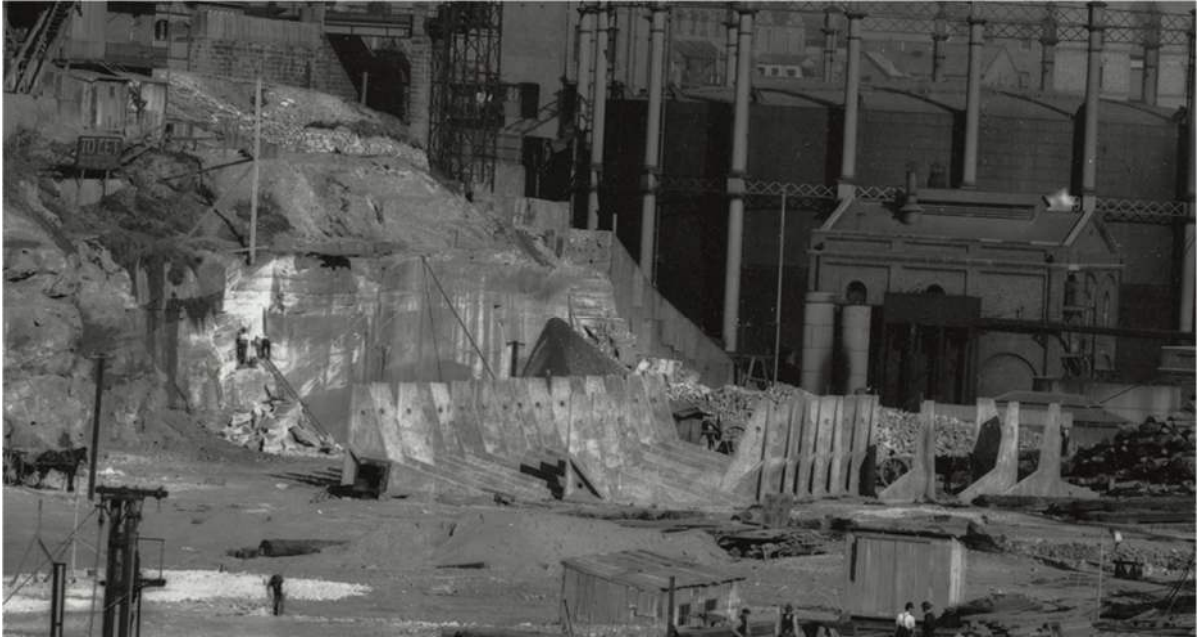
Figure 3.56: Detail showing extensive bedrock modification to the north of the AGL Co Gasworks and the large gasholder, probably associated with the construction of Hickson Road. SRNSW, 'View of the reconstruction of Darling Harbour from Millers Point showing Dalgetys Wharf No. 1 partly completed', 01/01/1909, 9856_a017000007.

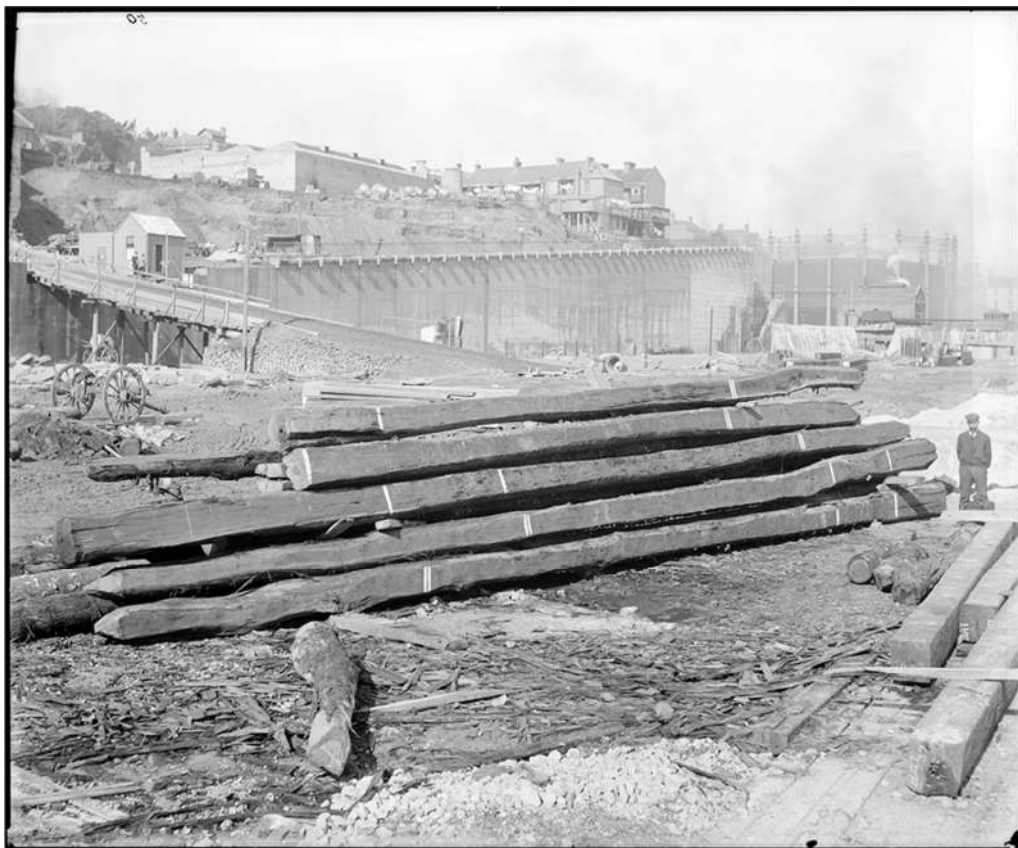
Figure 3.57: Pre-1911 Photograph showing the construction of Hickson Road in the vicinity of the study area, with the Gasworks and large gas annulus visible in the background. SRNSW, 'Millers Point and Hickson Road (Under construction) with Sydney Gasworks gasometer at right', no date, glass plate negative, NRS-9856-3-18-MSBL529.

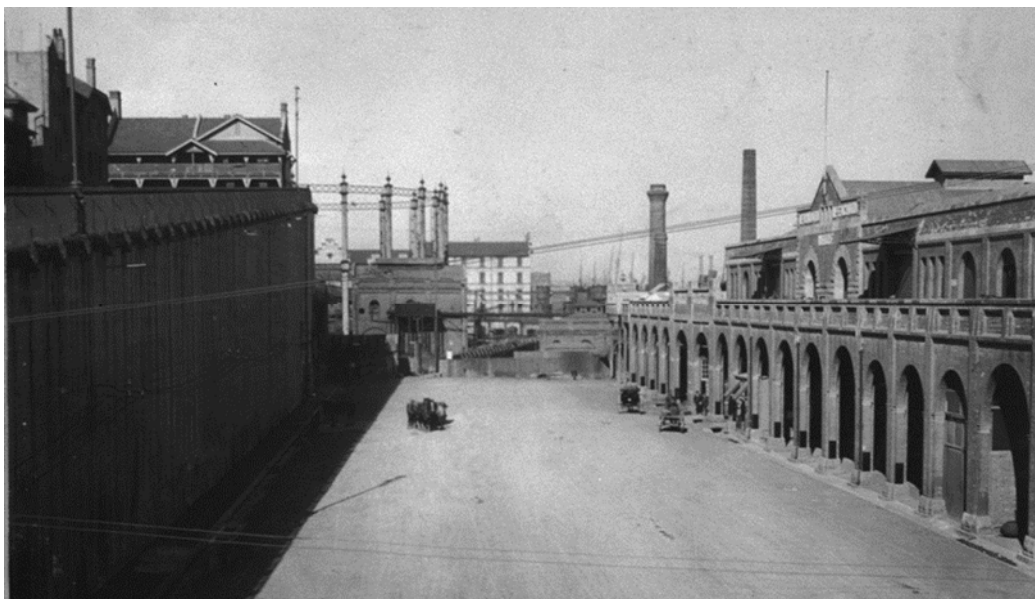
Figure 3.59: 'Gasworks at end of Hickson Road'. Hickson Road could not be completed until the Gasworks was decommissioned. Government Printing Office 1 - 24734, Original negative held by State Archives & Records Authority of New South Wales. SLNSW, nX6I2VLY.

On 30 September 1921 AGL absolutely and finally relinquished its foundation site to the Sydney Harbour Trust.¹⁶⁰ This opened the way to the completion of Hickson Road, which had been blocked by the AGL works (Figure 3.59).

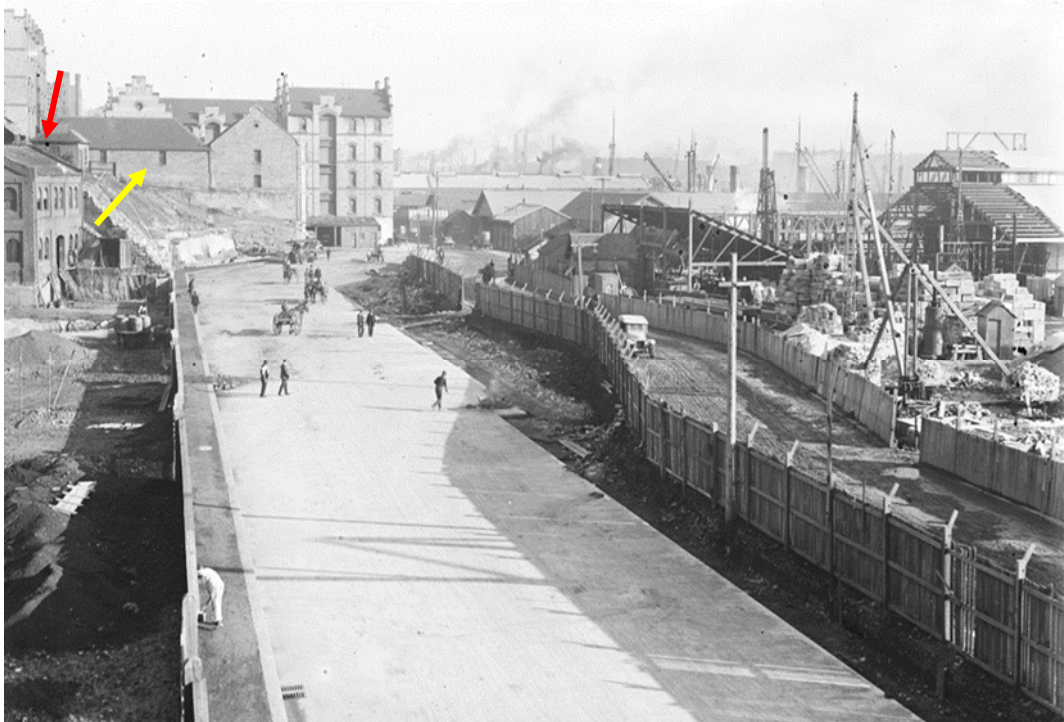
Figure 3.61: Construction of Hickson Road through the former Gasworks site 1923, looking south. Note the front part of the remaining MSB Store Complex building (red arrow). The five-storey building blocking Hickson Road to the south is part of Grafton Bond, soon to be demolished. The 1860s stone store (yellow arrow) built by Smith and Challis, later named Store F. Only the eastern building was retained and the western building was demolished. Note in the photo how the eastern part of Store F is set into the high rock shelf. The temporary road on the West is shown in use. The adjoining slope was quarried to achieve the modern streetscape. NSWSA, NRS-9856-2-142-6454.

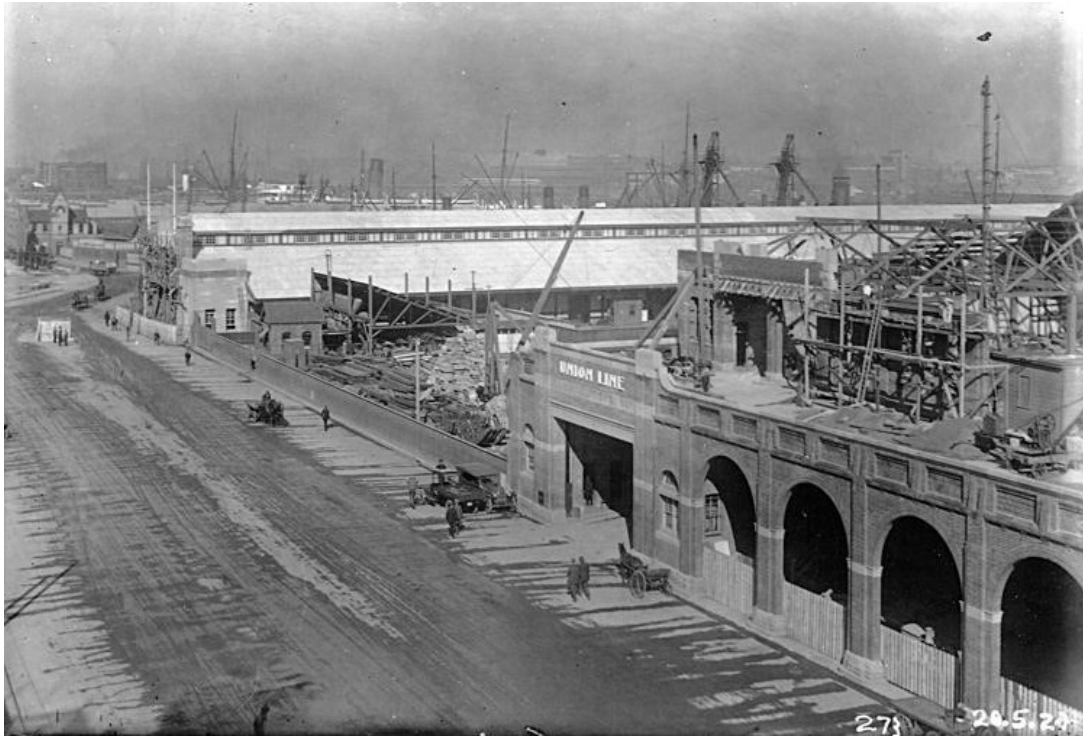
Figure 3.62: The new wharves adjacent to Hickson Road on the AGL site in May 1924. CSA, 086/086897.

By 1924 Hickson Road had been driven through the AGL site and berth 5 to the west was nearing completion. The new wharves matched the height of Hickson Road, with the adjacent example consisting of a timber-framed structure with a brick façade and double-storey road frontage (Figure 3.62). The construction of wharf 5 had involved:

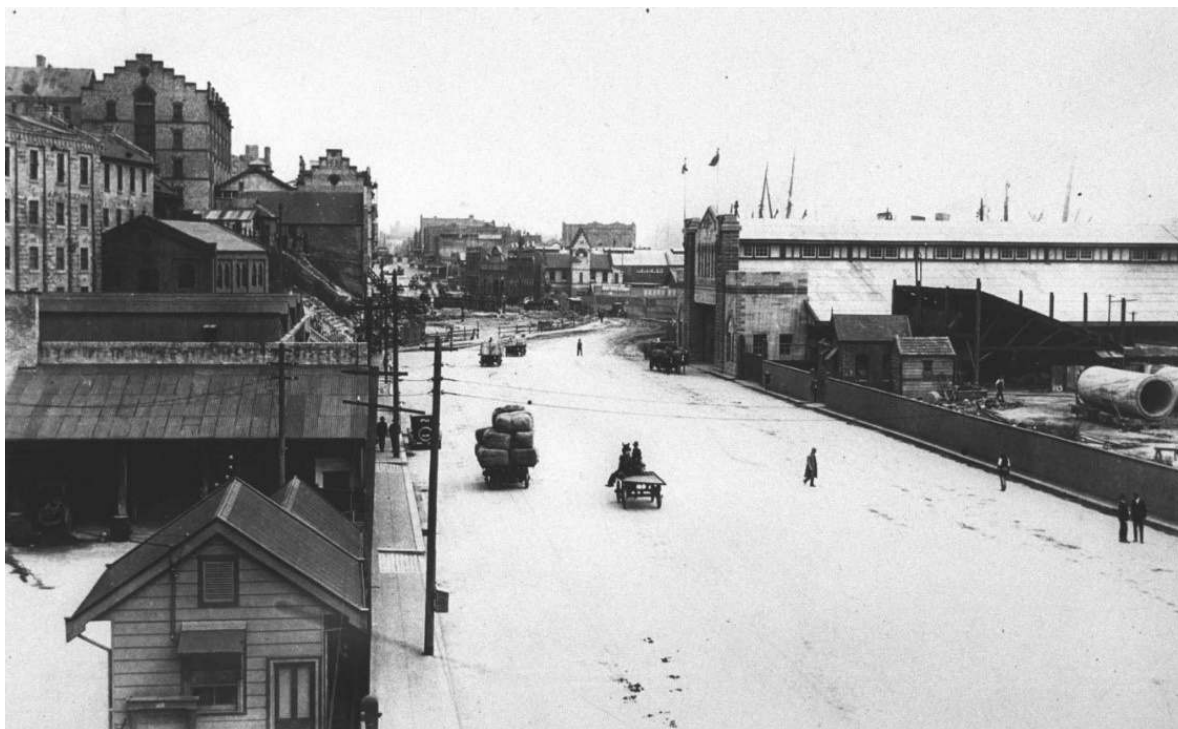
Figure 3.64: On the left, Sydney Harbour Trust buildings on the AGL site in 1928. SLNSW ML, GPO 1-19641.

Structural remains of similar timber wharf structures have previously been identified from archaeological excavations at Barangaroo South (Figure 3.63). While remediating the land formerly occupied by AGL buildings, the Sydney Harbour Trust erected two office buildings on the eastern side of Hickson Road, for the use of workmen, carpenters, blacksmiths and plumbers (Figure 3.64).
