HICKSON ROAD UPGRADE - STAGES 3 & 4

HISTORICAL ARCHAEOLOGICAL ASSESSMENT & IMPACT STATEMENT

NOVEMBER 2025

FINAL REPORT | to Infrastructure NSW and Lendlease (Millers Point) Pty Ltd

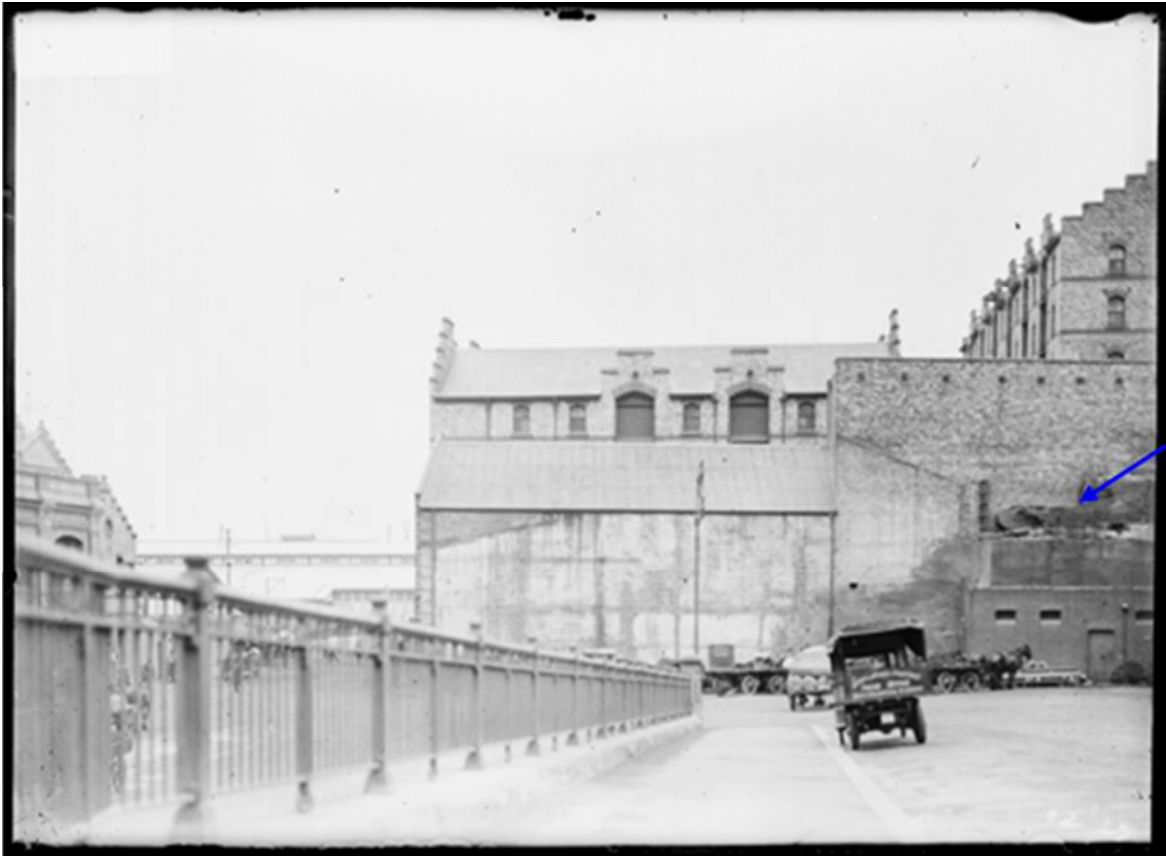
Figure 3.65: Looking down Napoleon Street towards the Grafton Bond Store c.1923 before the modifications to the façade. The quarried rock face is arrowed in blue. SRNSW NRS-9856-2-113-6334.

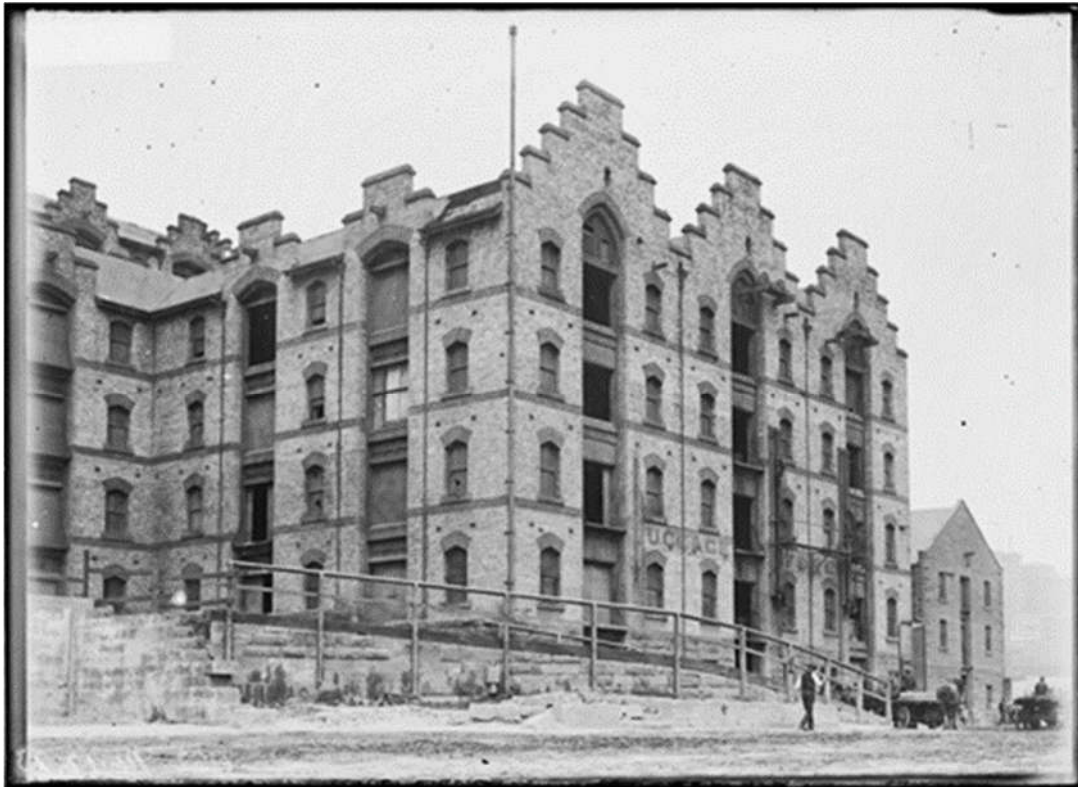
Figure 3.67: Grafton Bond Store with horse-drawn wagon handling materials', photo dated 4/12/1923. Note the fence at the front of the building suggesting a road sloping up to the north of the building. NSWSA, NRS-9856-2-113-6335.

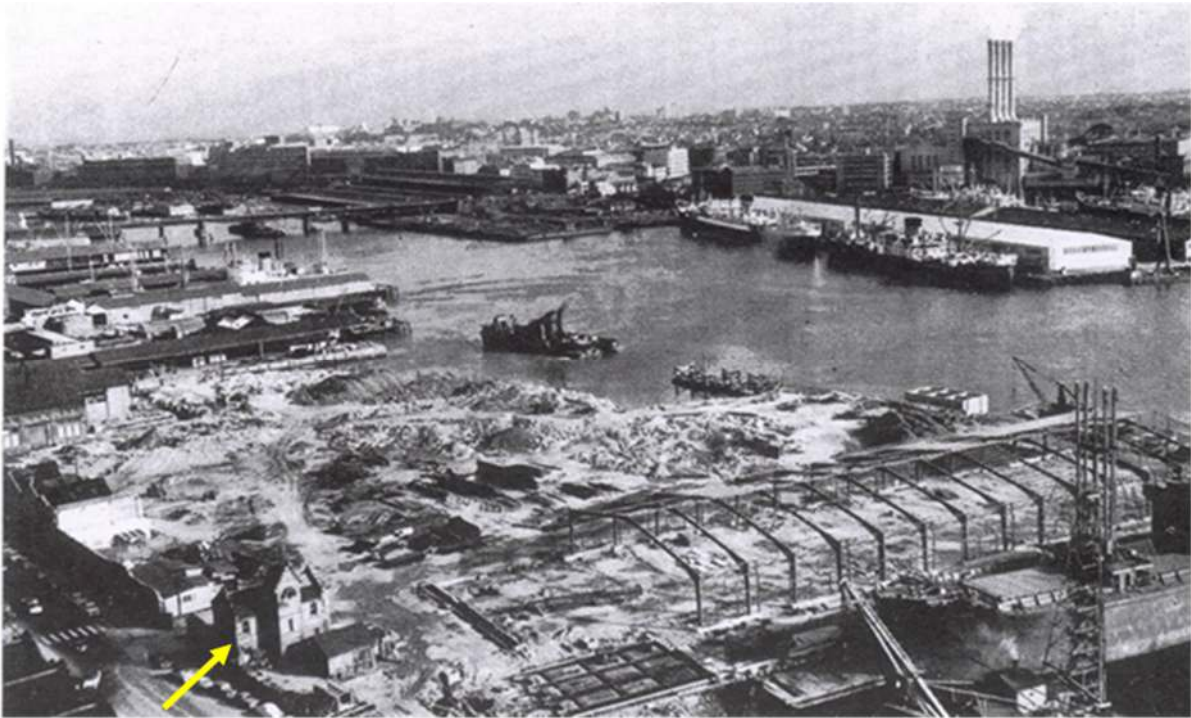
Figure 3.70: 1960s reclamation work in progress on the western side of Hickson Road to create lineal wharfage. Note the small Grafton Wharf tower building in the left foreground (yellow arrow) almost opposite the current study area. *Maritime Services Board 27th Annual Report* for year ended 30 June 1962.

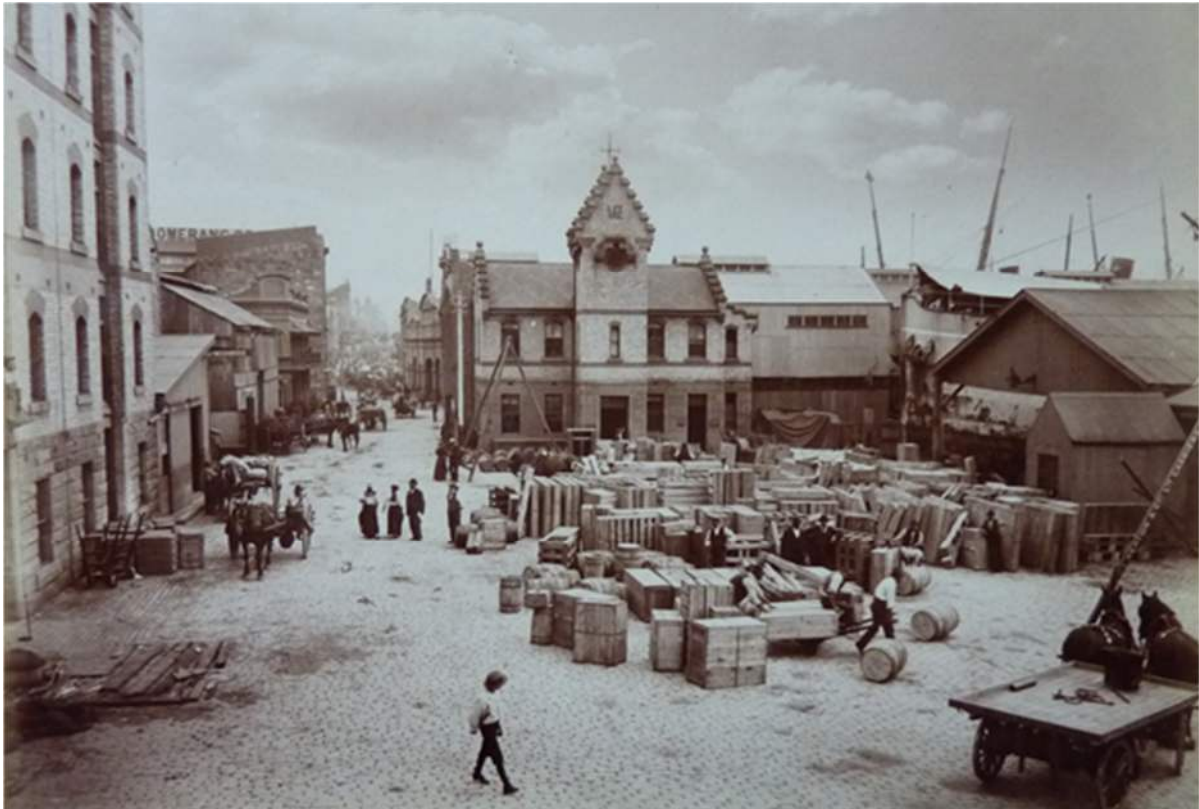
Figure 3.71: This 1870s photo shows the Grafton Bond store building (left) that was later modified for the construction of Hickson Road. The Grafton Bond clock tower building in the centre is the same building shown in Figure 3.29. Foundations of this building were found during the excavation of Barangaroo South, Stage 3 (2012). 1870s, Kerry & Co. SLNSW ML, PXA 449.

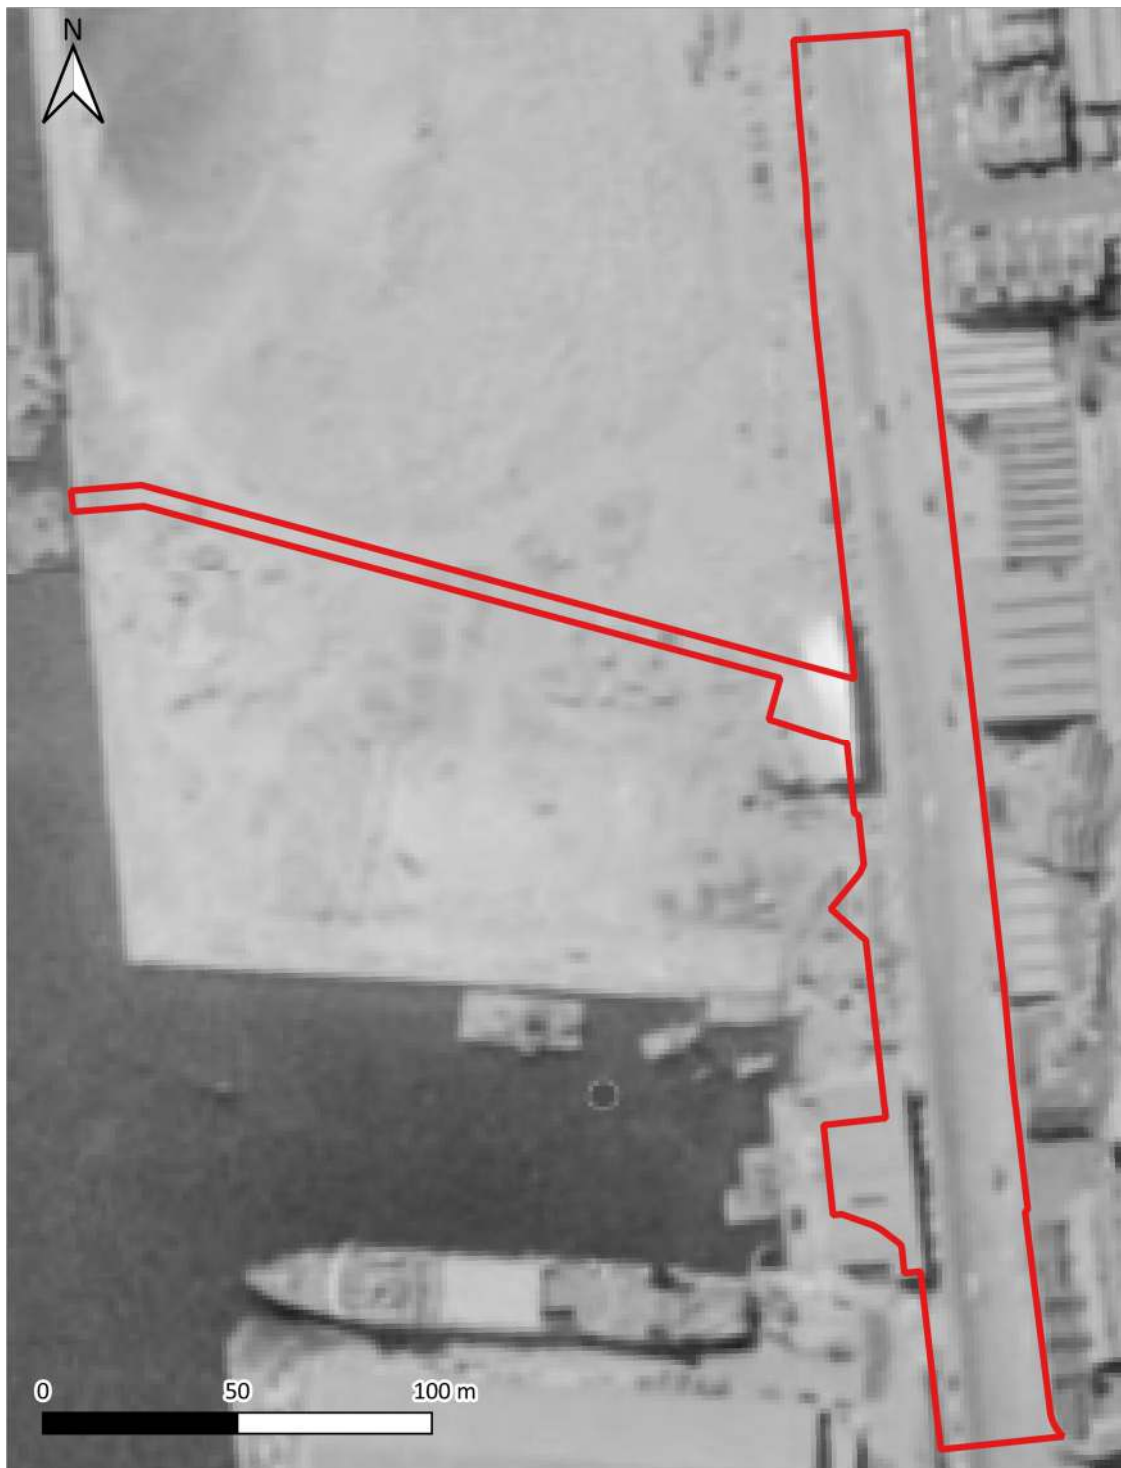
Figure 3.72: The study area in 1971, showing extensive reclamation to the west prior to the establishment of a large concrete apron for container ships. Historical Imagery Viewer.

semi-trailers to transport the goods (Figure 3.72). By the mid-1980s, Darling Harbour had become a major entertainment and tourist complex as part of a 1988 Bicentennial project. With the Walsh Bay Urban Renewal Project of the late 1990s proving such a success, in 2003 NSW Premier, Bob Carr, announced leases at Darling Harbour East, White Bay and Glebe Island would not be renewed. An international design competition was held, and in February 2007 the Minister for Planning announced his approval of a concept plan for the newly named Barangaroo (west of Hickson Road), to be redeveloped between 2008 and 2020.

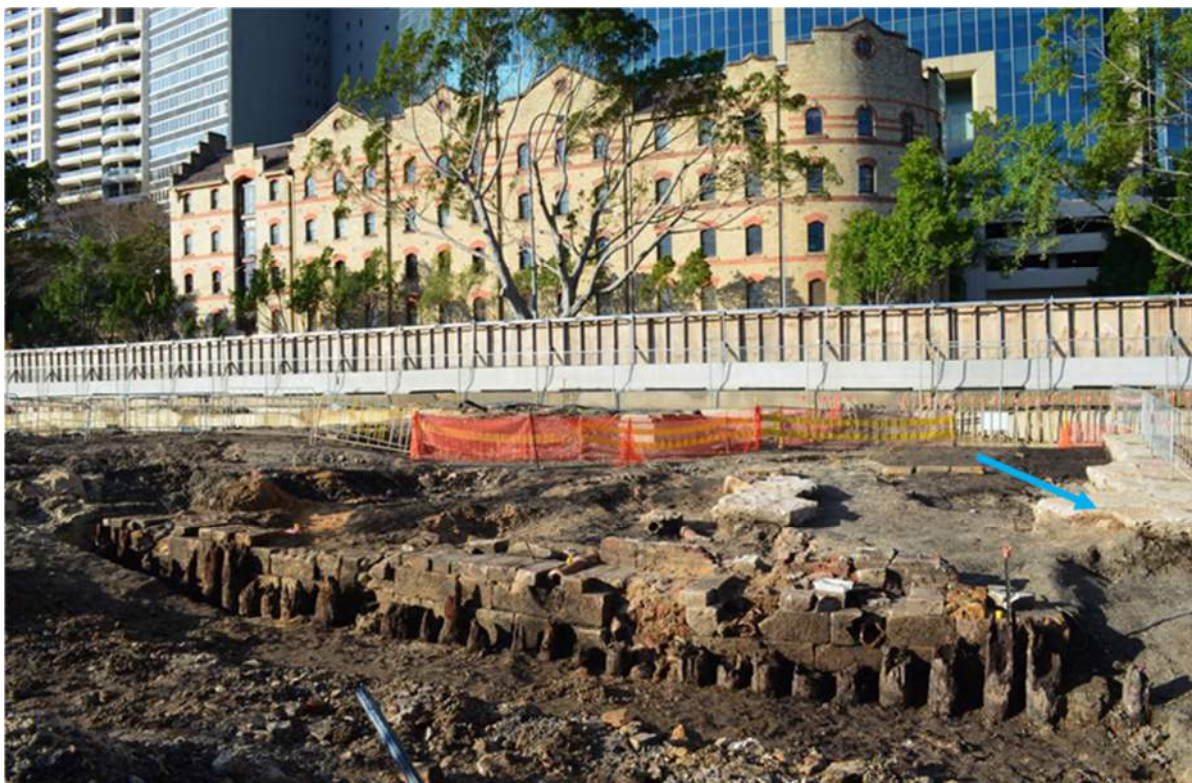
Figure 4.3: In the foreground is part of c.27m of sandstone seawall. On the right (blue arrow) are the concrete footings for the Flemish-style building. In the background is the rebuilt bond building on Hickson Road both part of the Grafton Bond stores. View to northeast. Casey & Lowe 2012.

The footing remains of the southern wall of the Flemish-style building were found during excavation and consisted of cyclopean concrete (Figure 4.3, Figure 4.4) and not sandstone blocks. There was evidence of the ground level being raised. Photographic evidence from the 1880s shows new surfaces of bluestone cobbles laid throughout the complex. Although there was no in situ archaeological evidence of bluestone paving found in the area around the Flemish-style building, pieces of bluestone paving were found in modern cuts dug after the building was demolished in the 1960s.¹⁸² In addition, the footing remains of the western wall of Bond Store C of the Grafton Bond was uncovered in Area P up to two courses surviving and laid on a concrete base (Figure 4.5).¹⁸³

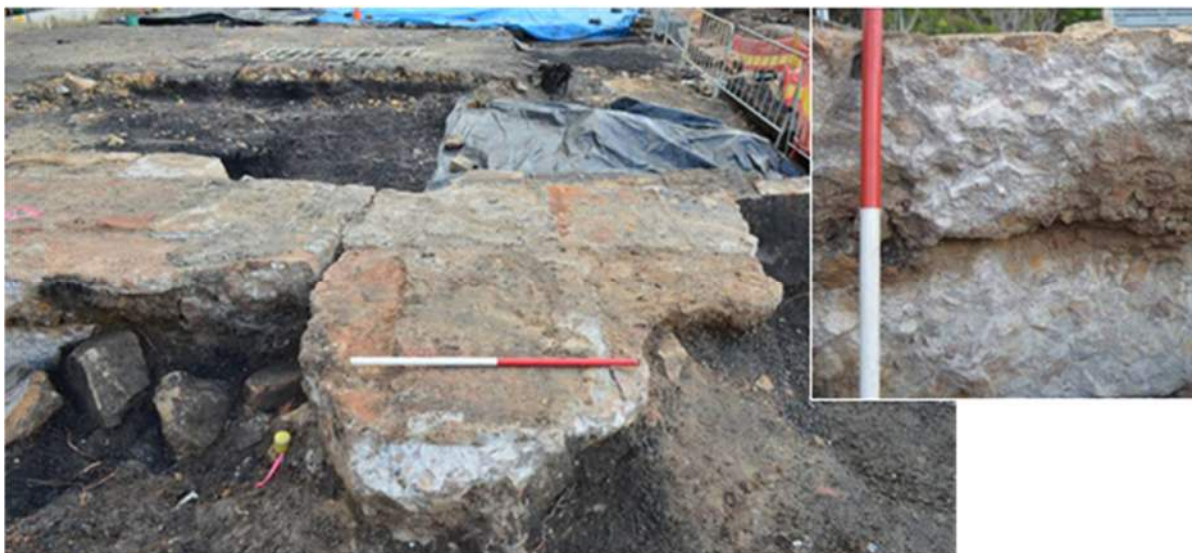
Figure 4.4: Part of the 1880s concrete footing of the Flemish-style building with an inset detail showing the sandstone fragment aggregate. Scale 1m. View to south. Casey & Lowe 2012.

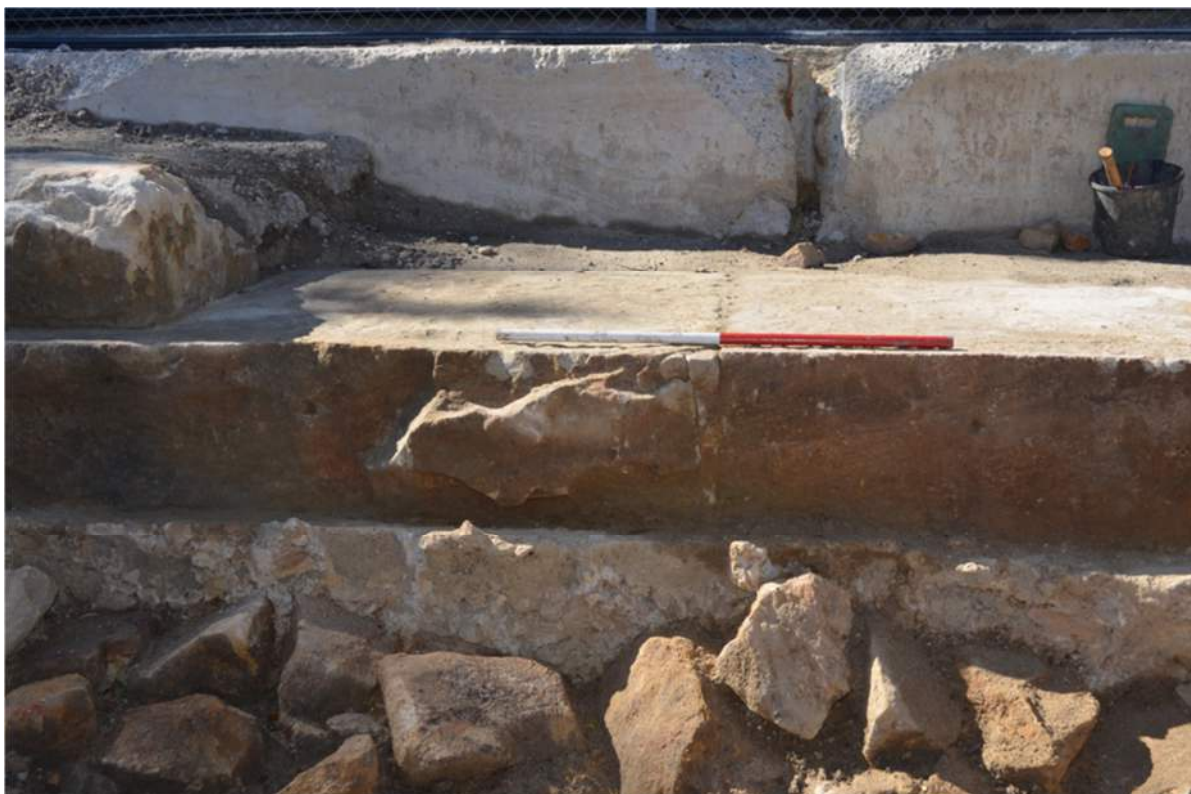
Figure 4.5: The footing of the Grafton Bond Store showing the sandstone rubble 'formwork' (bottom), the cyclopean concrete (context 12813 above), and the lowest course of sandstone blocks (centre of image, context 12806). Scale 1m. View to east. Casey & Lowe 2022d.

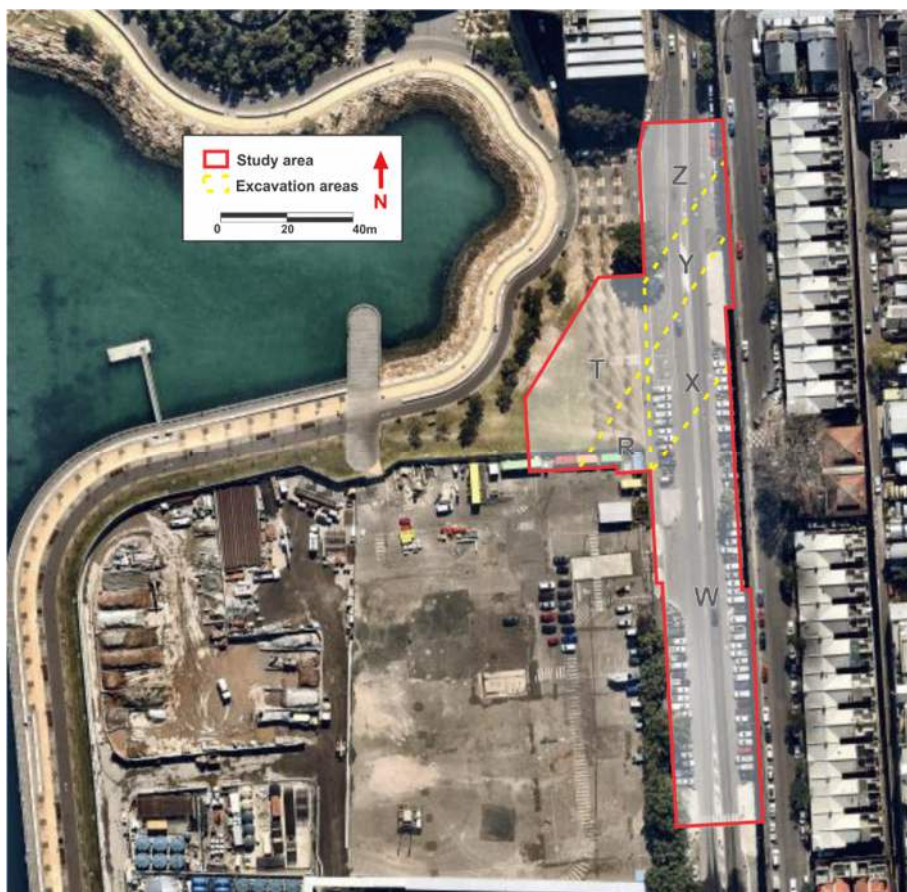
Figure 4.6: Location plan showing the site outlined in red and the excavation areas hatched in yellow. Casey & Lowe, Preliminary Results Report 2019.

Casey & Lowe were commissioned by AMBS Ecology and Heritage on behalf of Transport NSW to undertake historical archaeological investigations at the Barangaroo Metro site, Sydney. The archaeological resource of the site was assessed as being of local heritage significance. A rare abandoned vessel discovered buried in harbour silts was assessed as being of State significance. The site is located within and to the west of Hickson Road, Barangaroo, within the City of Sydney. Much of the site is directly adjacent to High Street in the east (Figure 4.6). The excavation program took place between July and December 2018.¹⁸⁴

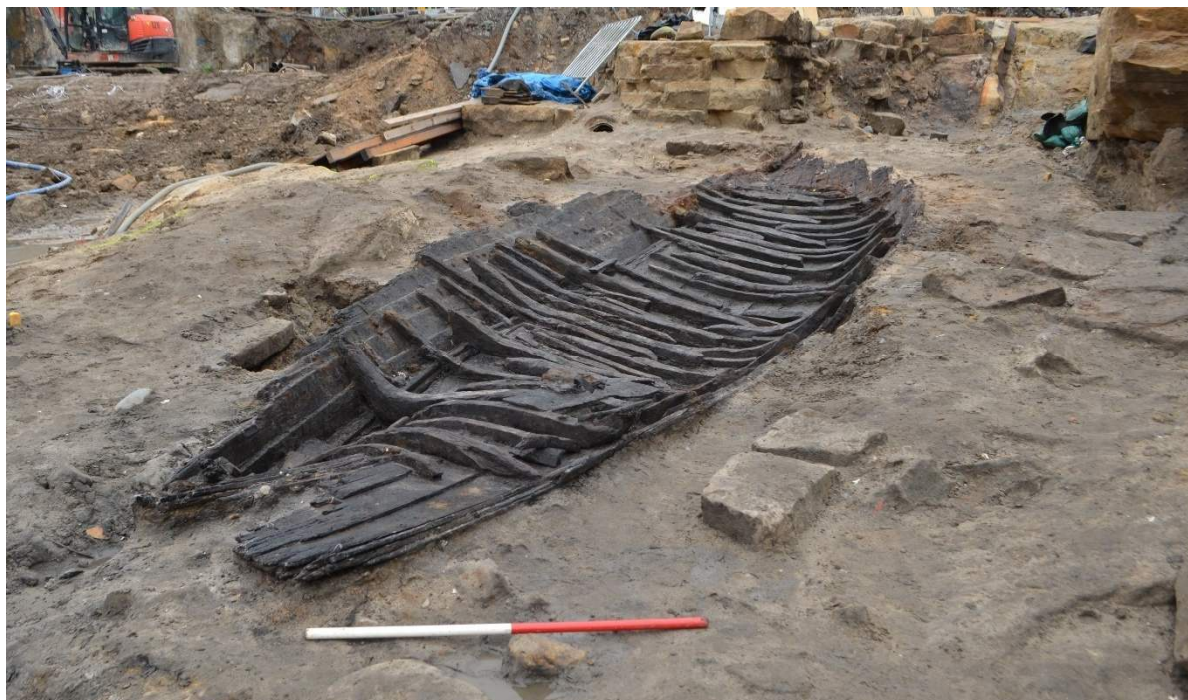
Figure 4.8: View of the abandoned timber boat found in the intertidal zone at the foot of the historical location of Clyde Street partly beneath an 1850s seawall. Casey & Lowe, Preliminary Results Report 2019

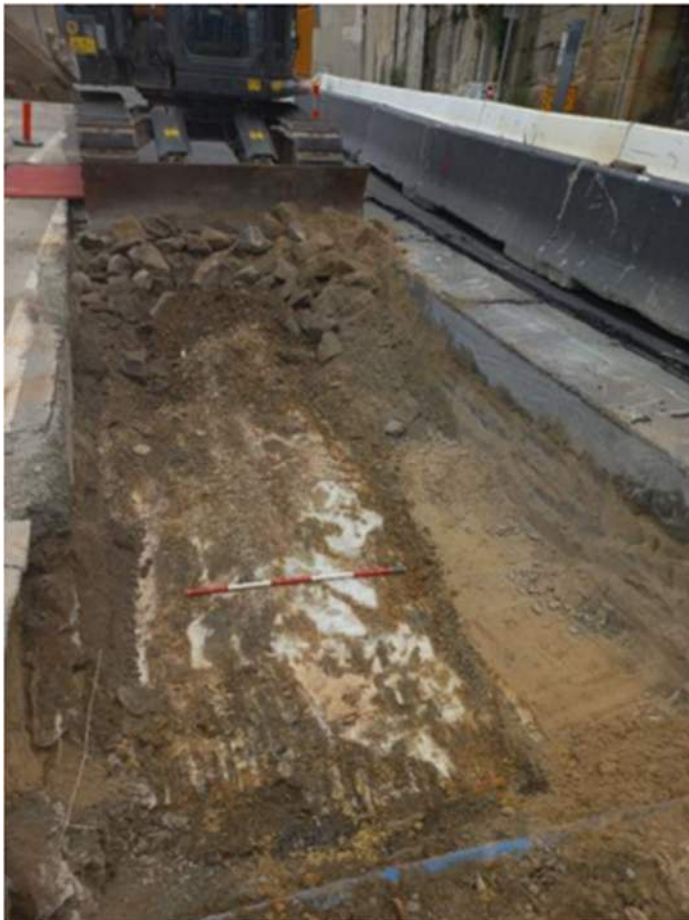
Figure 4.12: Cut bedrock observed in the base of Trench 2.2. The High Street wall is visible in the background. AMBS 2024, Figure 4.17.

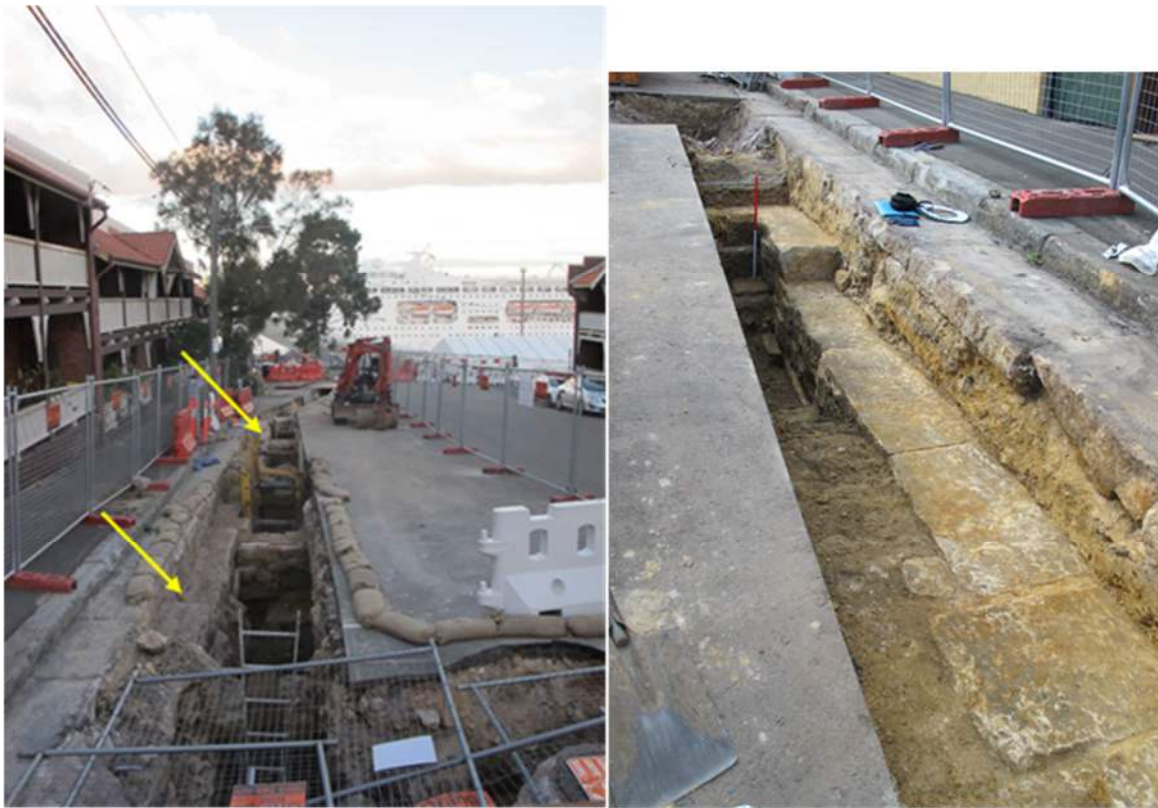
Figure 4.14: Trench for new stormwater service on the southern side of High Street. Left: The arrows indicate the main southern wall of the building which extended deep below the current street level. Right: View to east showing detail of the main sandstone wall.

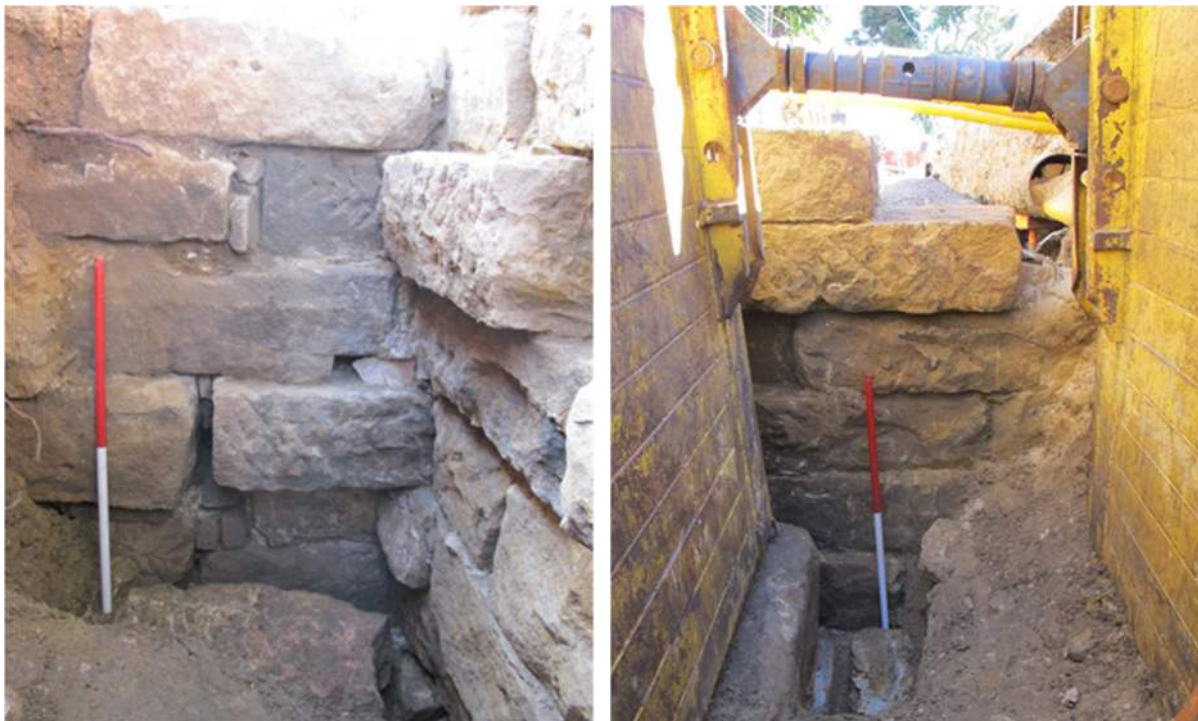
Figure 4.15: Photos showing the depths of the sandstones walls to accommodate the natural topography. The floor in each room dropped in level from east to west from about 400mm to 2.2m below modern street level.

The main east-west wall of the structure was constructed down the steep sloping landscape and was seen to be cut into the natural clay and bedrock. Given the steepness of the topography, at the eastern end of the trench the main east-west wall was three courses that rested on the natural while at the western limit of the trench, the wall was ten courses over a footing course. At the western end the ground level was estimated to be over 2m below the current street level (Figure 4.14, Figure 4.15). The archaeological evidence strongly indicates that the structural remains are of one construction phase dating to at least the 1850s and therefore they cannot be the remains of the Agars building depicted on these plans from the 1830s, although some of the lower courses of stone appear different and are the potential remains of the earlier 1830s building.

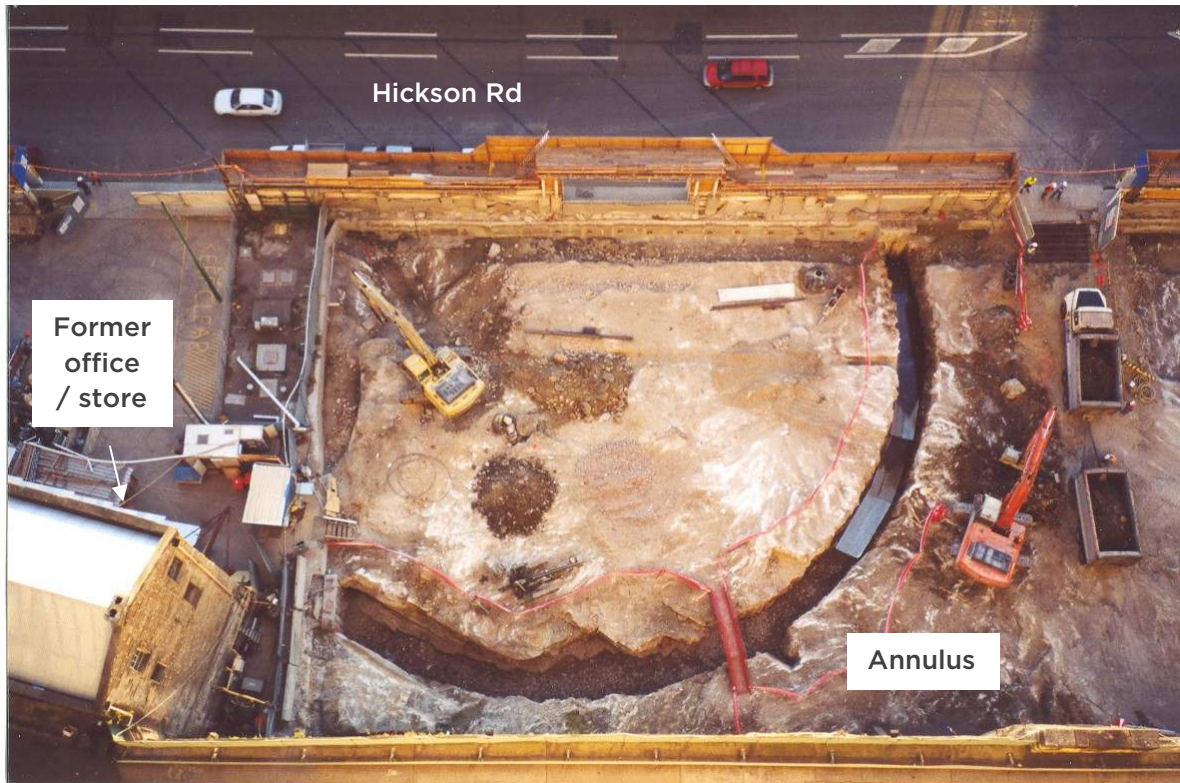
Figure 4.16: Aerial view of the 1882 gasholder annulus recorded at 30-34 Hickson Road, Millers Point (shown to continue under Hickson Road). Image provided by Mark Burns, Lendlease (2002).

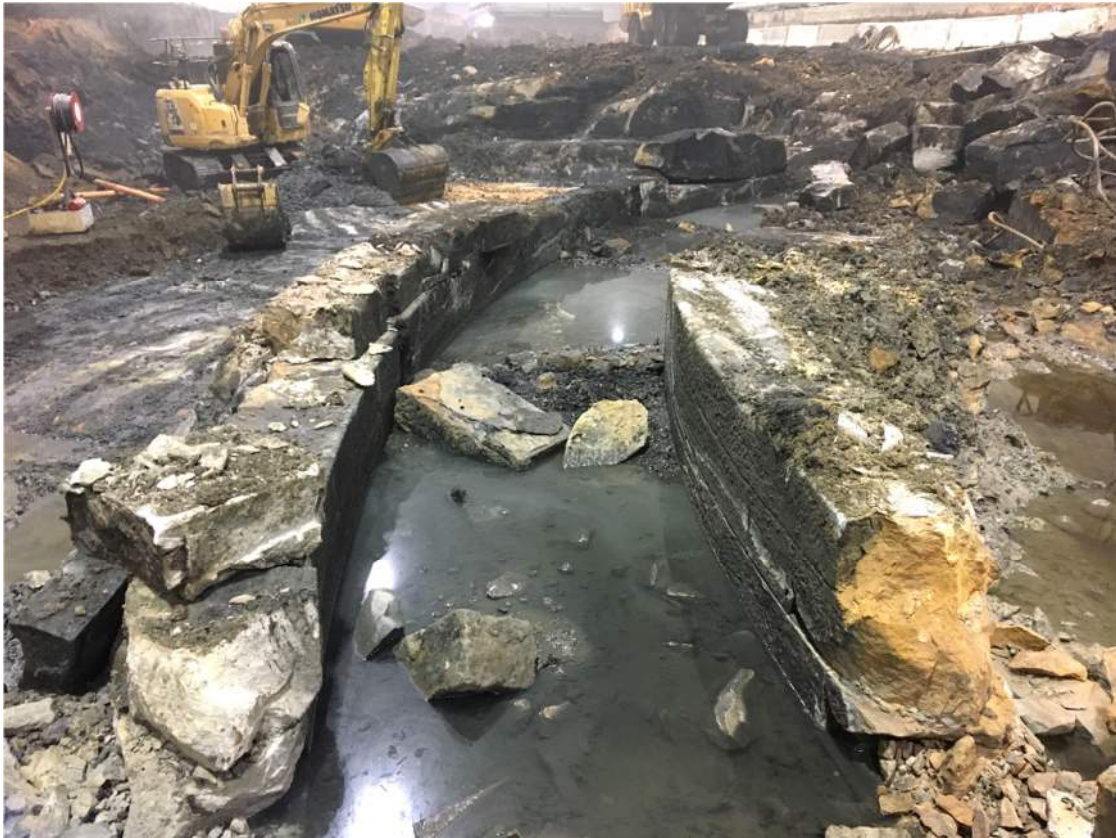
Figure 4.20: Excavation of the 1870s gasholder annulus within Block 4. Lendlease 2019.

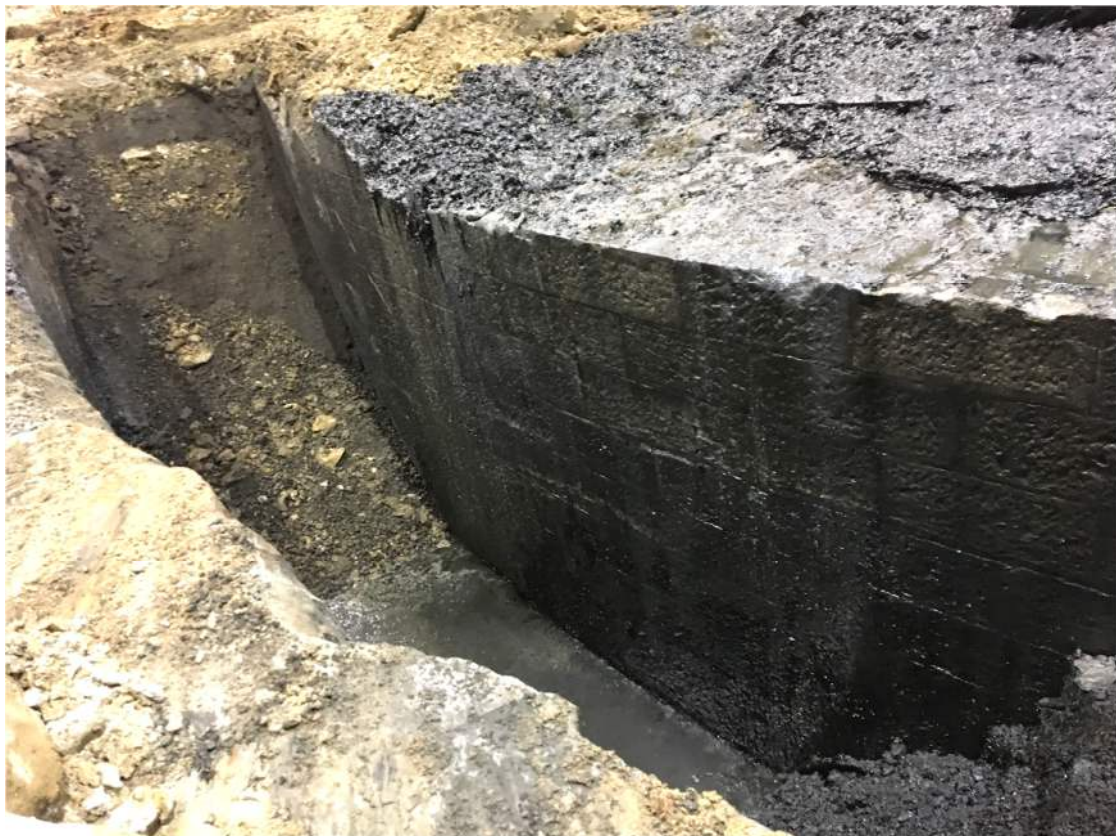
Figure 4.21: Excavation of the 1870s gasholder annulus within Block 4, showing the worked sandstone blocks used in the construction. Lendlease 2019.

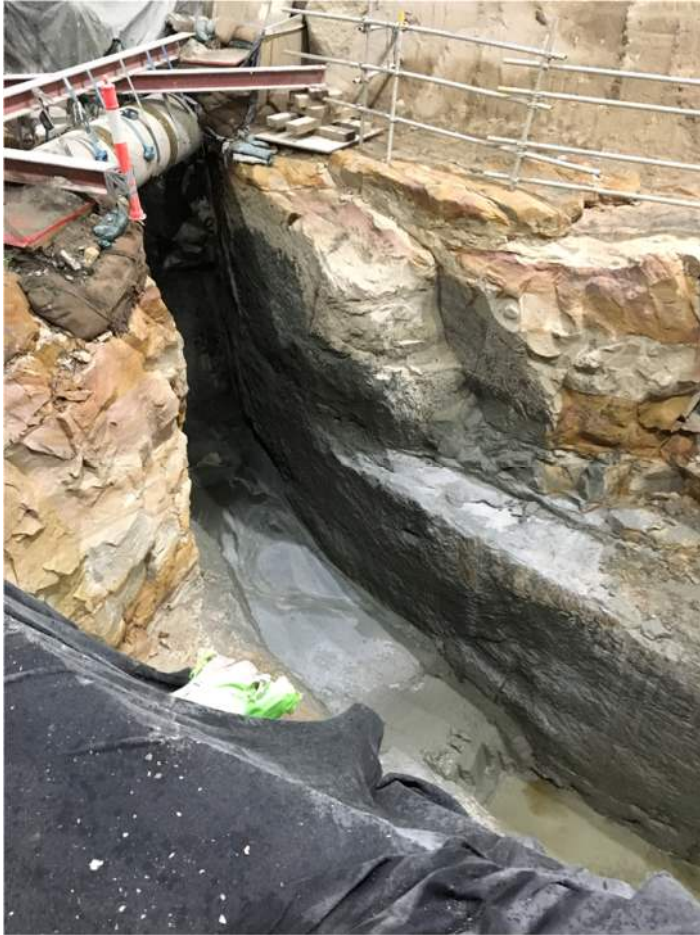
Figure 4.22: The 1870s gasholder annulus within Hickson Rd, cut into the bedrock. Lendlease 2019.

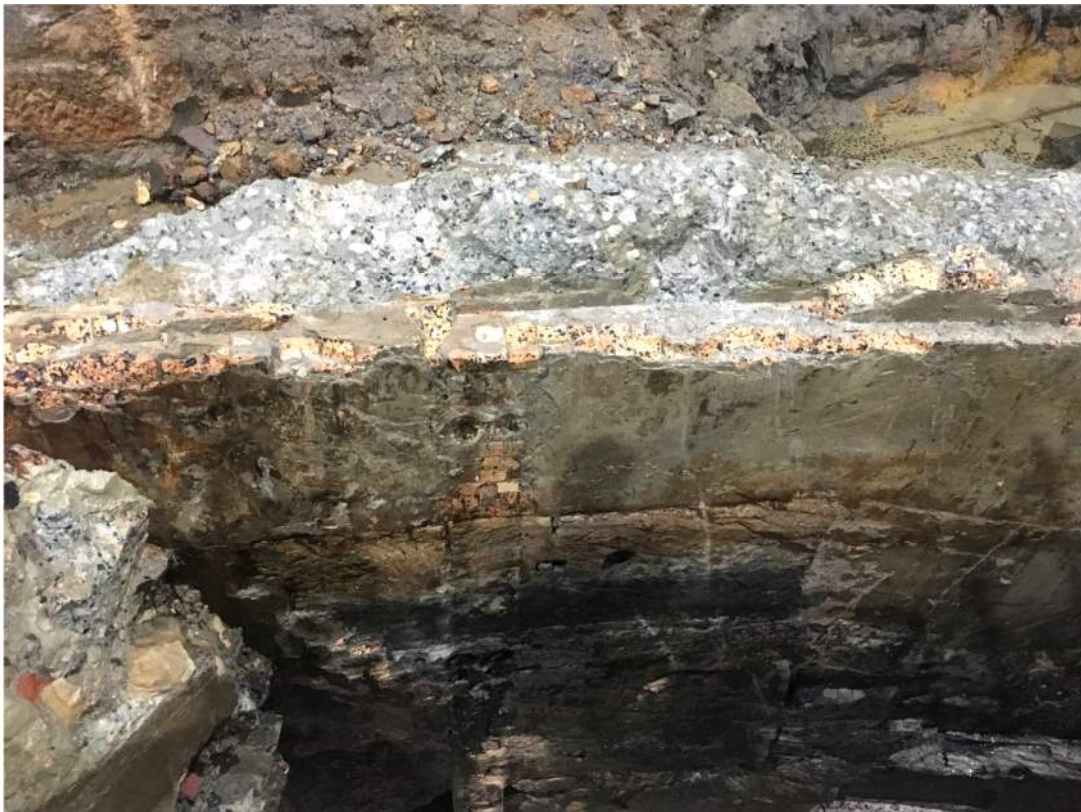
Figure 4.23: Detail of a section of the 1882 gasholder annulus wall comprised of a brick wall with a cement render, Hickson Road. Lendlease 2019.

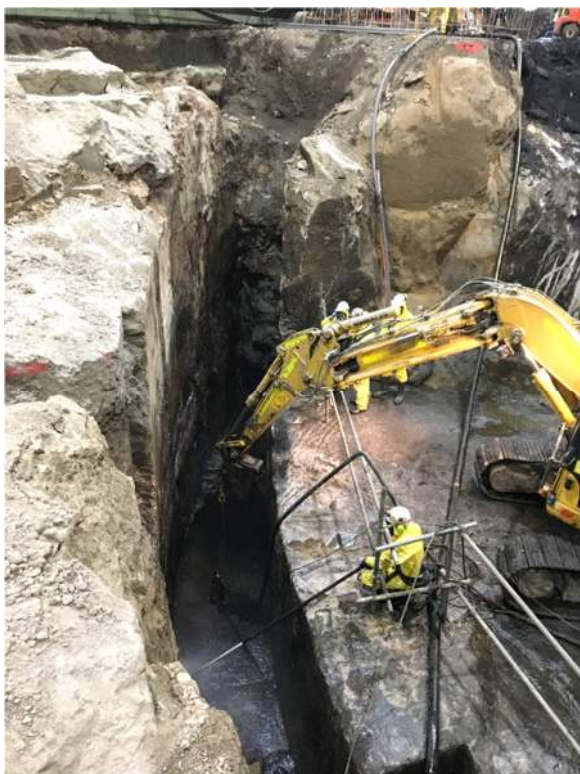
Figure 4.24: Excavation of the 1882 gasholder, excavated into the natural sandstone, under Hickson Road. Lendlease 2019.

Structure	Location	Dimensions	Type of Structure encountered
1870s Gasholder Annulus <i>Gasholder 4</i>	Block 4 / Hickson Rd	Depth - 9.2m below ground Width (of annulus trench) - 2m	Sections of the annulus walls were found to be constructed of sandstone blocks, particularly where there was surrounding fill material (Figure 4.20, Figure 4.21). Remaining areas were natural sandstone bedrock (Figure 4.22). The base was natural sandstone bedrock.
1882 Gasholder Annulus <i>Gasholder 5</i>	Hickson Rd	Depth - 9.2m below ground Width (of annulus trench) - 2m	Some sections of the annulus walls comprised brick or cement rendered brick (Figure 4.23). This was generally in the upper portion of the annulus to top of natural bedrock (1-2m depth). Exception to this was where the annulus cut through the (earlier) small gasholder resulting in some deeper sections of brick wall (-5-6m depth). In remaining wall areas and the base, the structure was natural sandstone bedrock (Figure 4.24, Figure 4.25).

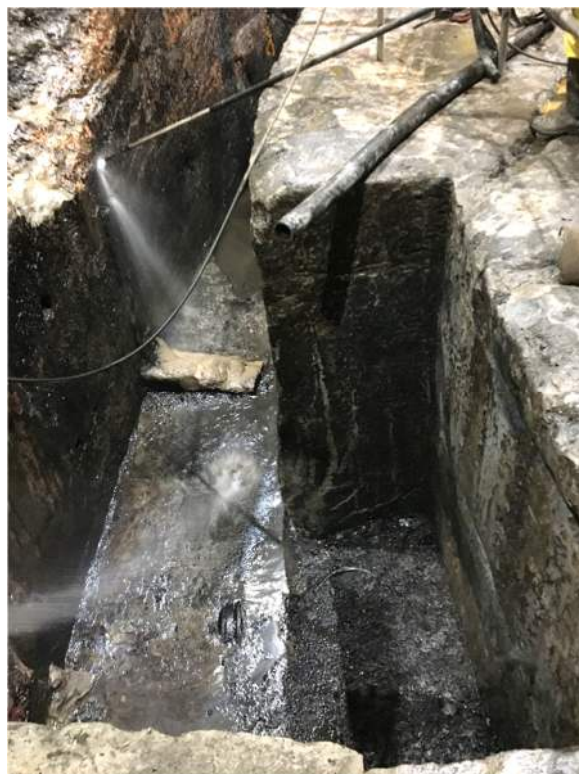
Figure 4.25: Excavation of the 1882 gasholder, excavated into the natural sandstone, under Hickson Road. Lendlease 2019.

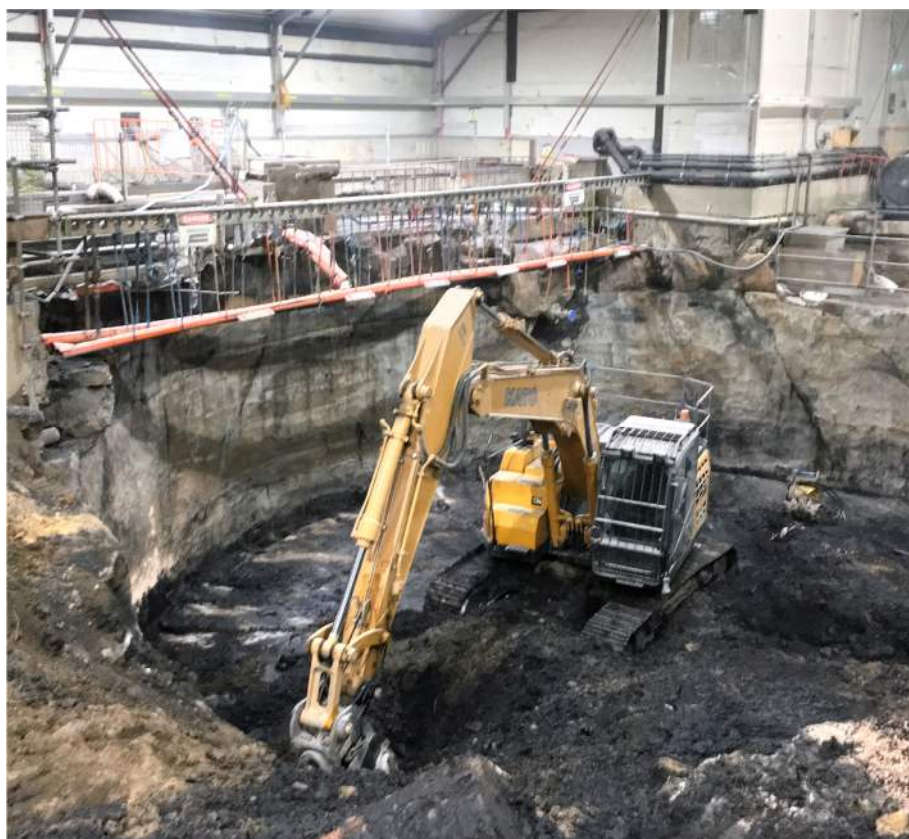
Figure 4.26: Cleaning out of the tar tank, excavated into the natural sandstone, under Hickson Road, cutting sandstone bedrock. Lendlease 2019.

Tar Tank converted c.1870 <i>Gasholder 3</i> (c.1850s)	Hickson Rd	Depth - 5.6m below ground Diameter - 15m	The base and walls were unlined, natural sandstone bedrock (Figure 4.26, Figure 4.27, Figure 4.28).
Tar Well	Hickson Rd		Encountered on the northwest corner of the tar tank.
1839-42 Small gasholder <i>Gasholder 2</i>	Hickson Rd	Depth - 5.7m below ground Diameter - 15m	Generally, sandstone bedrock for the walls and base, except for some areas of brick wall or concrete where later structures/services cut through (Figure 4.29).

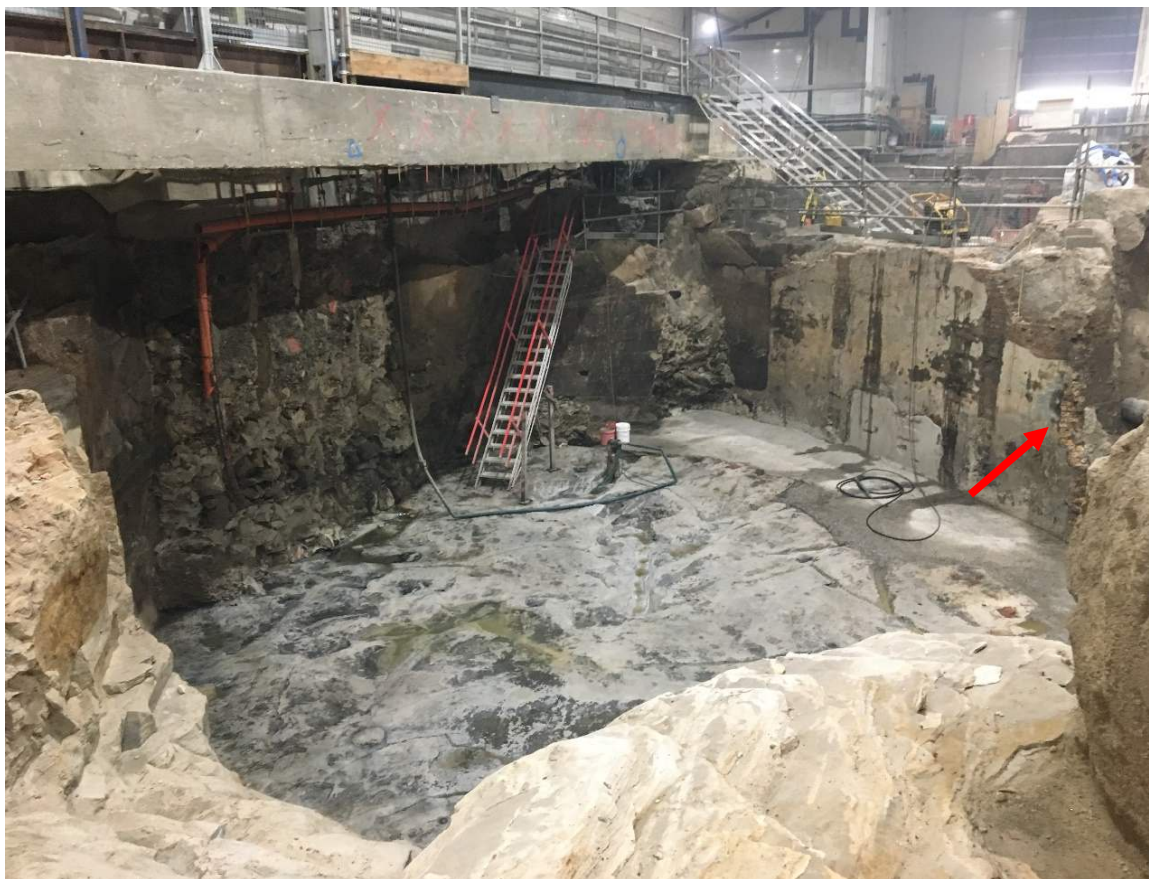
Figure 4.29: Excavation of the small gasholder under Hickson Road, cut into bedrock. A section of brick wall is visible to one side (arrowed). Lendlease 2019.

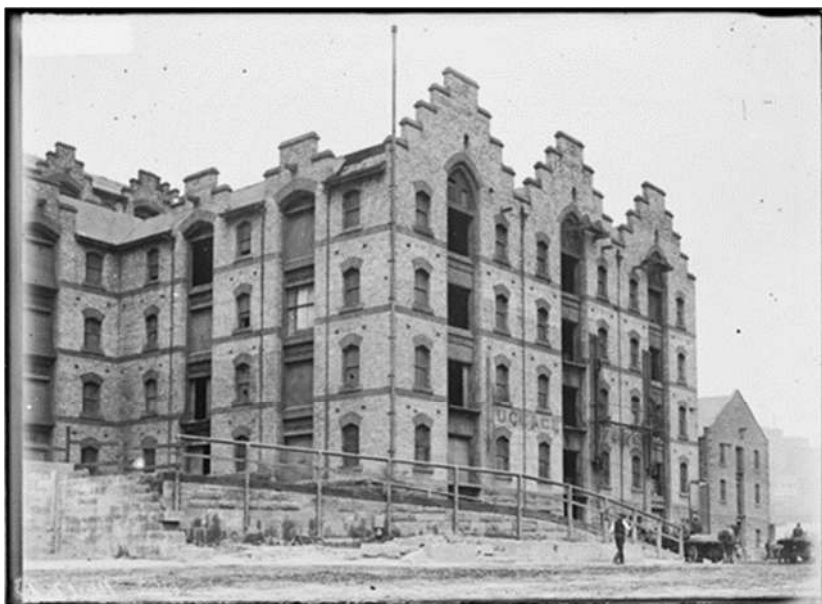
Figure 5.15: Grafton Bond Store with horse-drawn wagon handling materials', photo dated 4/12/1923. Note the fence at the front of the building suggesting a road sloping up to the north of the building. SRNSW Photo Investigator, Digital ID: 9856_2017_2017000264.j pg.

There is a **High potential** that the foundations of the demolished Grafton Bond buildings survive intact, including possible isolated artefact deposits. Several stores were either fully demolished or partly demolished and had new facades built to match the new Hickson Road alignment (Figure 3.61, Figure 5.15, Figure 5.16).²⁰⁷ These included Stores A, B, C, E and part of F, as labelled on the 1911 plan of Darling Harbour and which are highlighted in Figure 5.17. The footings of these buildings or associated remains may potentially remain *in situ*, as evidenced in a surviving bond store wall (Store C) during the Barangaroo South excavations by Casey & Lowe (Figure 4.5).²⁰⁸ The works on the Grafton Bond Stores and Hickson Road in the 1920s involved the excavation of bedrock when the stores were demolished. Excavation was required to prepare a level surface for the construction of the new Hickson Road. Any surviving remains may also be impacted by this early 20th-century road construction and the installation of buried services beneath the road. However, deeper archaeological features, such as wells and cesspits may also survive as they are features with deeper subsurface, which gives them a higher level of chance to survive 20th-century impacts.
