HICKSON ROAD UPGRADE - STAGES 3 & 4

HISTORICAL ARCHAEOLOGICAL ASSESSMENT & IMPACT STATEMENT

NOVEMBER 2025

FINAL REPORT | to Infrastructure NSW and Lendlease (Millers Point) Pty Ltd

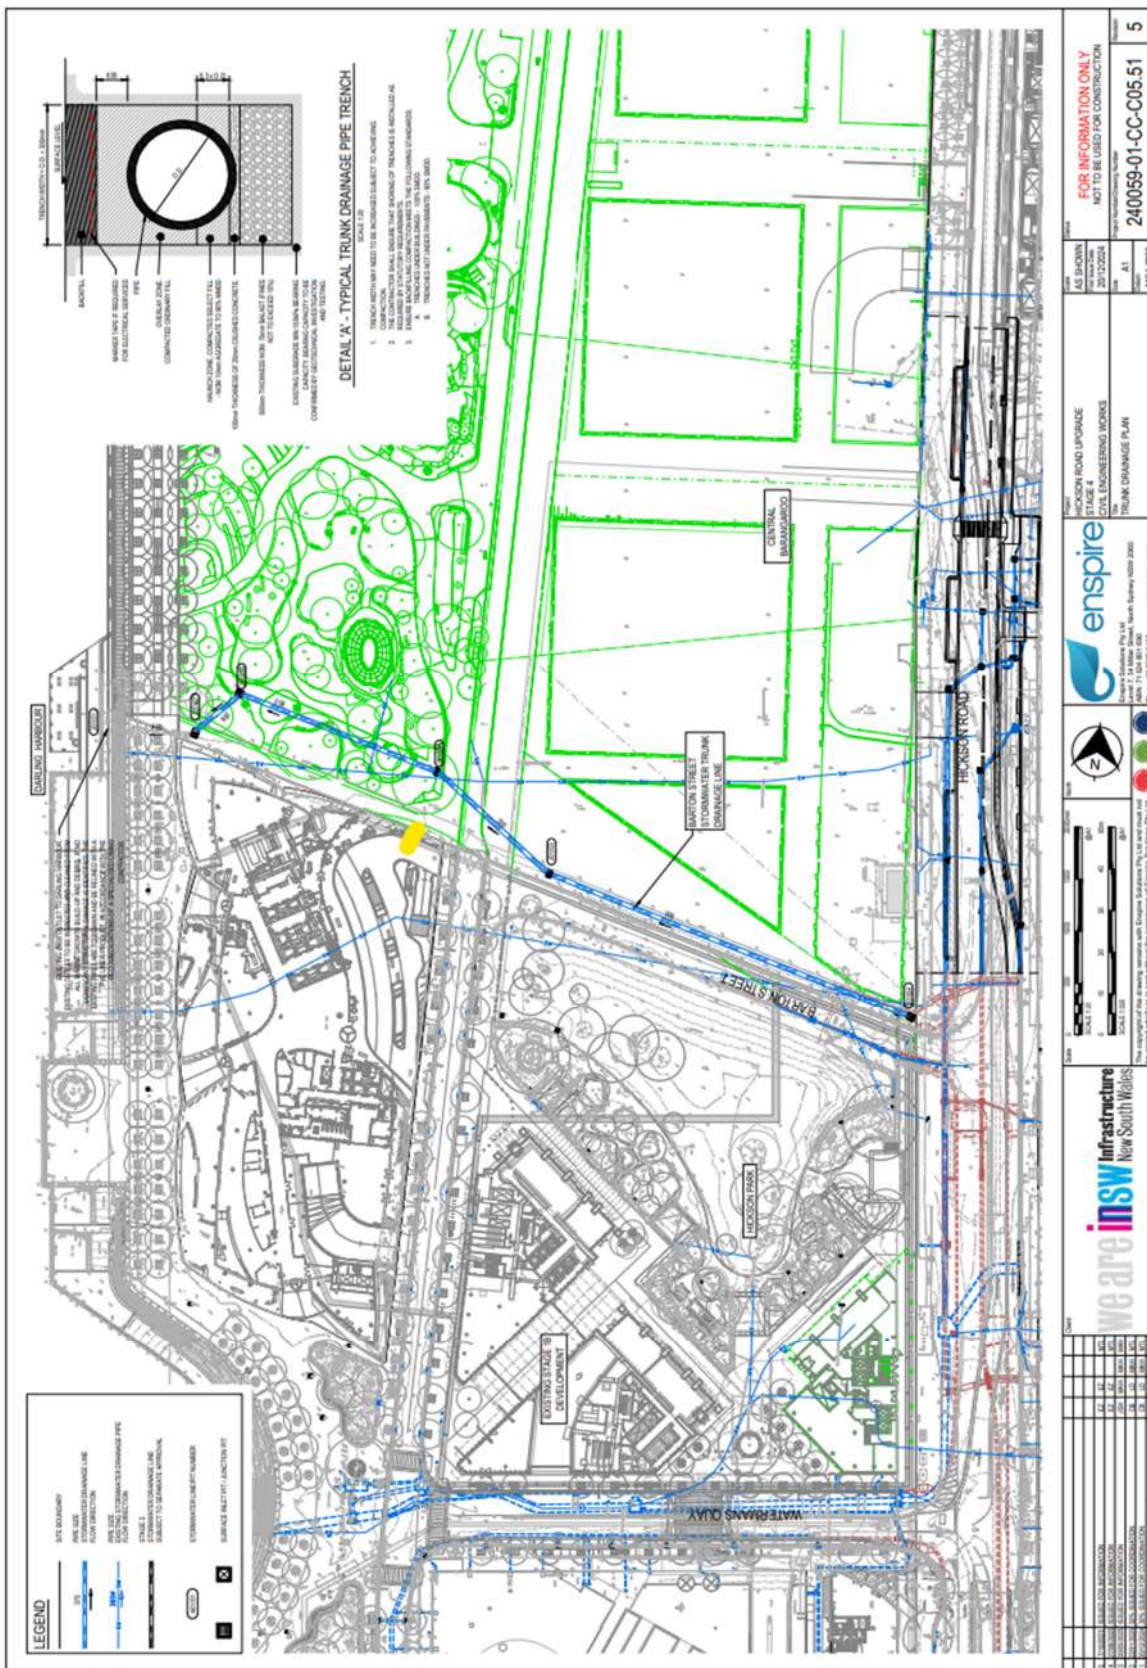
Figure 7.7: Proposed Stage 4 trunk stormwater line along the northern side of Barton Street. The stormwater line is represented by a checked blue line, and the Barton Street portion is indicated by a scalloped red line. Enspire Solutions Pty Ltd 2025, 240059-01-CC-C05.51.

- Removal of multiple existing stormwater pits.
- New stormwater inlet and junction pits at various locations throughout both stages.
- New stormwater drainage to be installed throughout the study area, including a new trunk drainage line adjacent to the northern side of Barton Street (Figure 7.7). Trenching for the new stormwater line is expected to measure up to 1.5m wide and generally between 1.5m and 3.2m deep, except the portion along Barton Street which is expected to reach a maximum depth of 3.7m towards the western extent.
- Adjustments to existing stormwater drainage pits to suit revised road levels
- Subsoil drainage behind kerbs and in landscaped medians.
